XPS-study of passivating films and their effect on plasma nitriding

THE INDUSTRIAL CHALLENGE

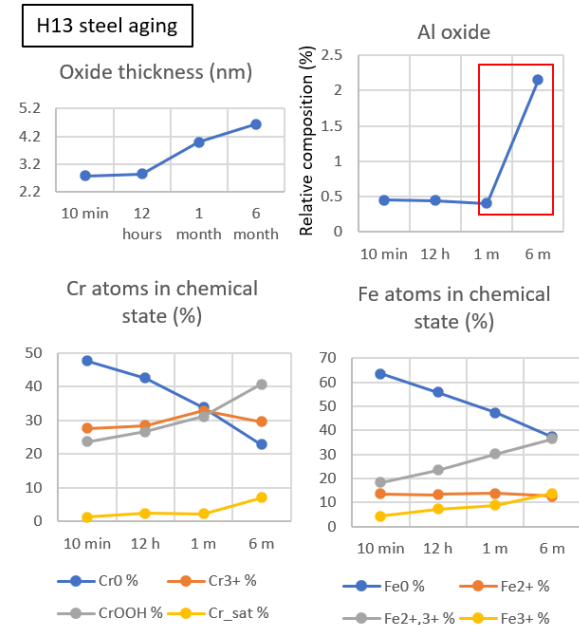
The results showed that aluminium oxide (Al_2O_3) was present in high concentrations in the gear roots of both H13 and Ovako Hybrid Steel. In the case of Hybrid Steel this was not unexpected since it contains a couple of wt% aluminium. For the H13 alloy it was more surprising since it contains only ~0.02 wt%. Aluminium evidently diffuses to the surface during the vacuum hardening performed after gear hobbing and forms an oxide. The room temperature experiments showed that aluminum diffuses to the surface of the H13 alloy, however the amounts are much lower (Figure).

Figure. Results of HAXPES illustrating diffusion of Al in H13 steel after 1 month ageing in air.

It has previously not been known what causes the passivation in gear roots, but following the HAXPES experiment it is clear that Al_2O_3 is present in high concentrations. Since Al_2O_3 is a very dense oxide, known to pacify surfaces, it is likely that it plays a large role for the resulting passive films at the gear roots. Now it is possible to start working on solutions to circumvent this passivation.
