Electrical joints optimized for increased thermal and mechanical fatigue life

Public report

Project within Circularity - FFI - Juni 2022

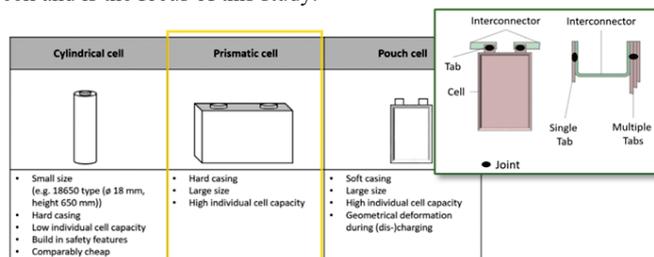
Figure 1 Schematic representations of three types of battery cell where the prismatic cell is of interest in this project. An inset of the welded busbar-tab connections is shown. Adapted from [2].

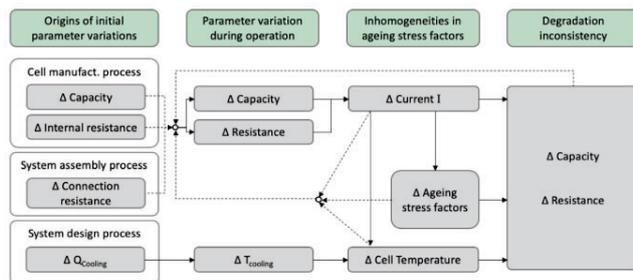
Figure 2 Map of thermal load and electrical property parameters that affect the performance degradation of a battery cell[3].

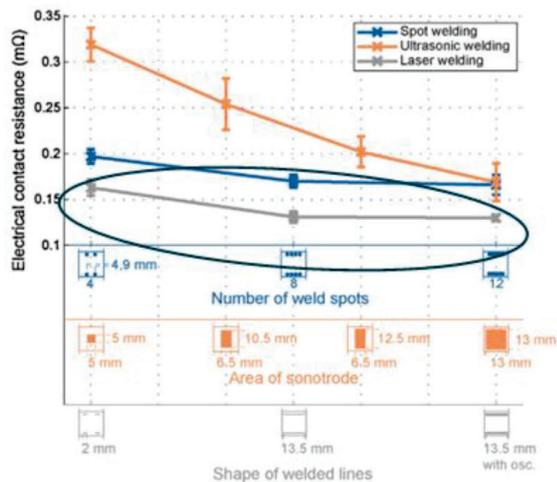
Figure 3 Electrical contact resistance vs. different welding parameters for resistance spot, ultrasonic, and laser welding of CuZn37 samples. Adapted from [5].

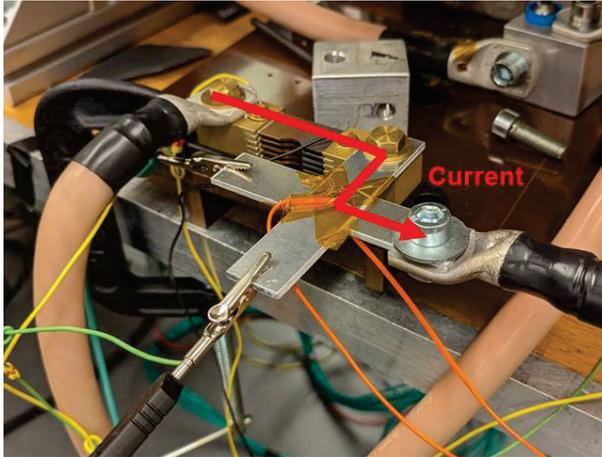
Figure 4 Fixture for applying high current and measuring temperature via thermocouples on the weld/front side and opposite side of a cross-sample.

Before performing fatigue testing as part of the main investigation, other tests were conducted to evaluate the performance of the fatigue test rig and to understand the magnitude of the temperature rise in the cross-samples subjected to high current. For this initial measurement of temperature at high current, a separate fixture was made (Figure 4).

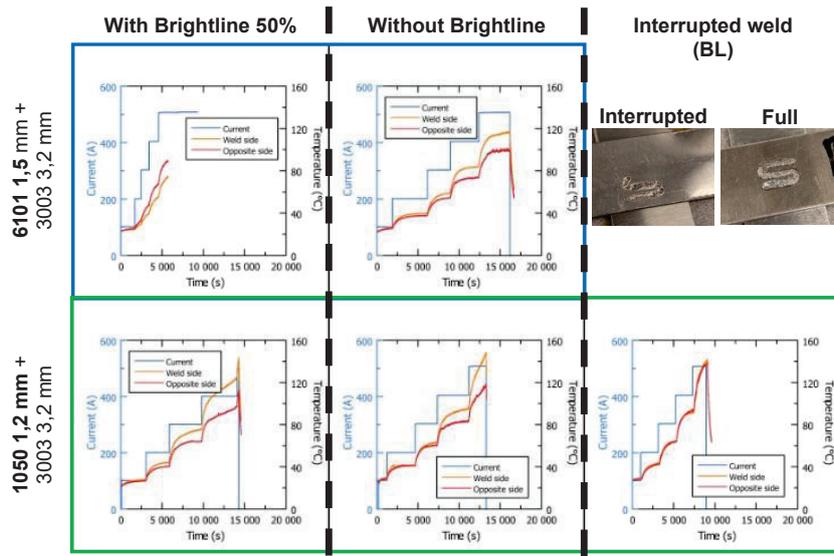
Figure 5 Temperature and current vs. time for the different material combinations and weld strategies performed for the initial evaluation of heat evolution in the cross-samples.

The results of this initial evaluation are shown in Figure 5. Higher maximum temperatures (145 °C-155 °C) at 500 A were observed in the material combination with the thinner 1050 tab compared to 120 °C in the 6101 material combination. Additionally, the interrupted S weld did not result in any significant difference in maximum temperature compared to the other 1050 material combination welds.

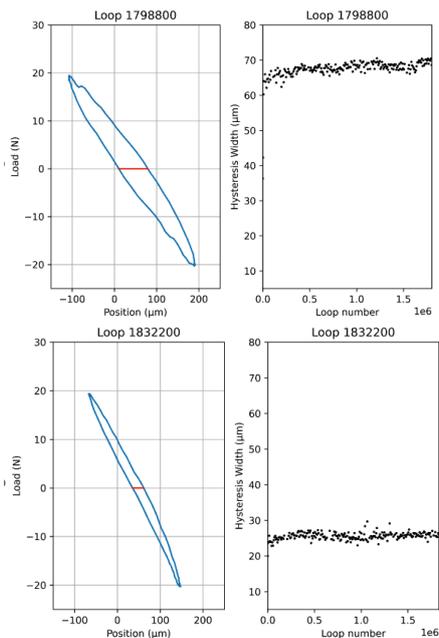
Figure 6 Force-displacement hysteresis loops and width of the hysteresis loops for the 1050-3003 (left) and 6101-3003 (right) material combinations. Both samples were laser welded with Brightline.

The same samples with Brightline and the full weld shape (i.e., those in the leftmost column in Figure 5) were also fatigue tested in the custom rig. Force-displacement loops and hysteresis widths for both samples are shown in Figure 6. In this initial test, the samples were subjected to a 20 N load amplitude at 10 Hz frequency for 1.8 Mcycles. Here, both samples survived the fatigue test without full fracture, but the hysteresis width of the 1050-3003 sample was noticeably larger than that of the 6101-3003 sample, which likely has to do with the larger thickness of the 6101 coupons (1.5 mm vs. 1.2 mm).

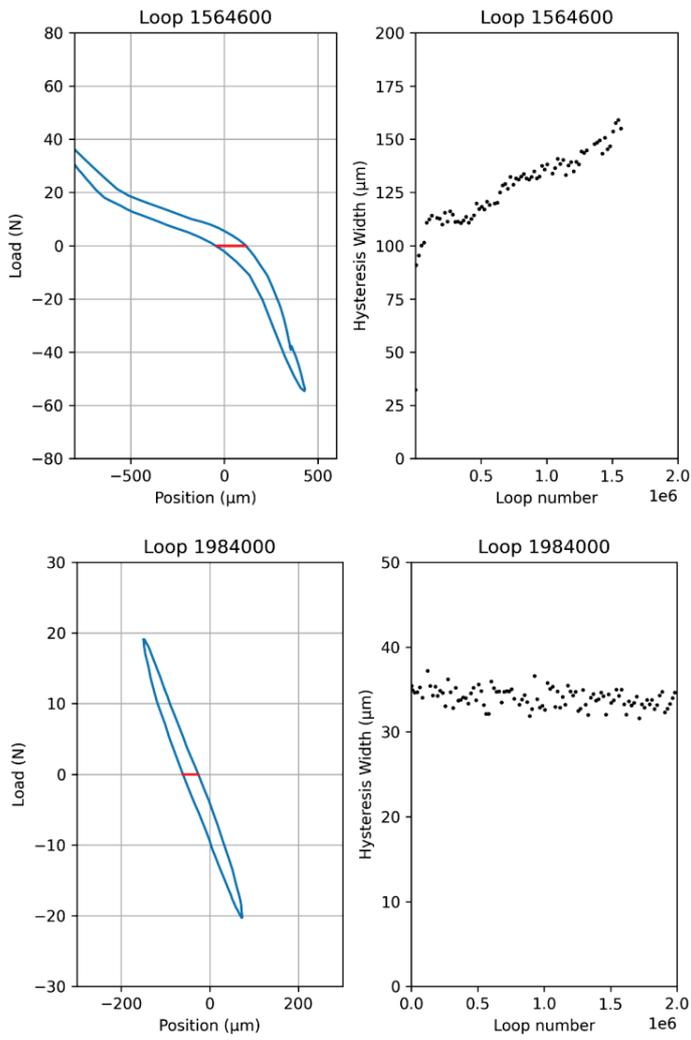
Figure 7 Force-displacement loops and hysteresis width for an S-shaped weld (top) and an O-shaped weld (bottom).

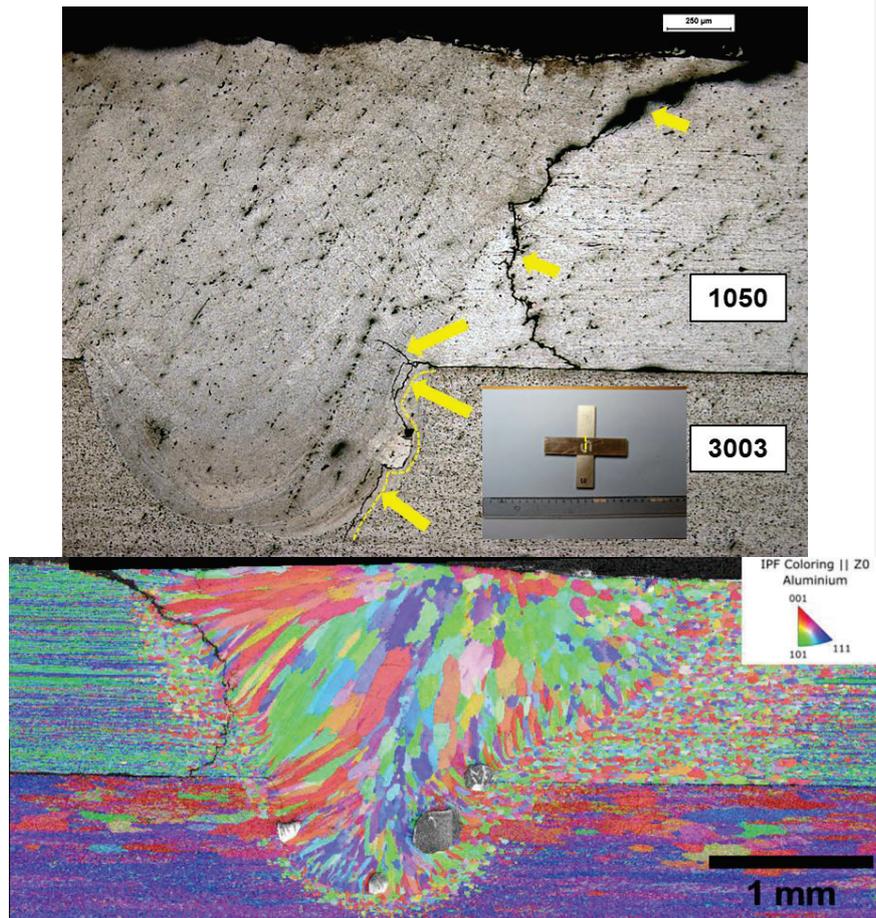
Figure 8 LOM image of a cross-section taken from the S-shaped weld after fatigue testing (top). Two main fatigue cracks are outlined with arrows. EBSD IPF of the same cross-section (bottom). Note that the images are mirrored.

LOM evaluation (Figure 8) of the S-shaped weld after fatigue testing showed the presence of two major fatigue cracks. One crack appears to have initiated on the surface of the 1050 tab away from the weld and then propagated along the laser weld fusion line before changing direction away from the weld, where the crack then appears to end at the sheet interface. The EBSD inverse pole figure (IPF) of the same weld shows clearly that the crack lies in the base material at the surface, and propagates along the heat affected zone (HAZ) and slightly inside the fusion zone. The other fatigue crack appeared to initiate at the junction between the weld fusion line and the sheet interface, where the crack then propagated and branched into the fusion zone. The longest branch of this crack propagated along the fusion line and just into the HAZ on the 3003 side (root side).

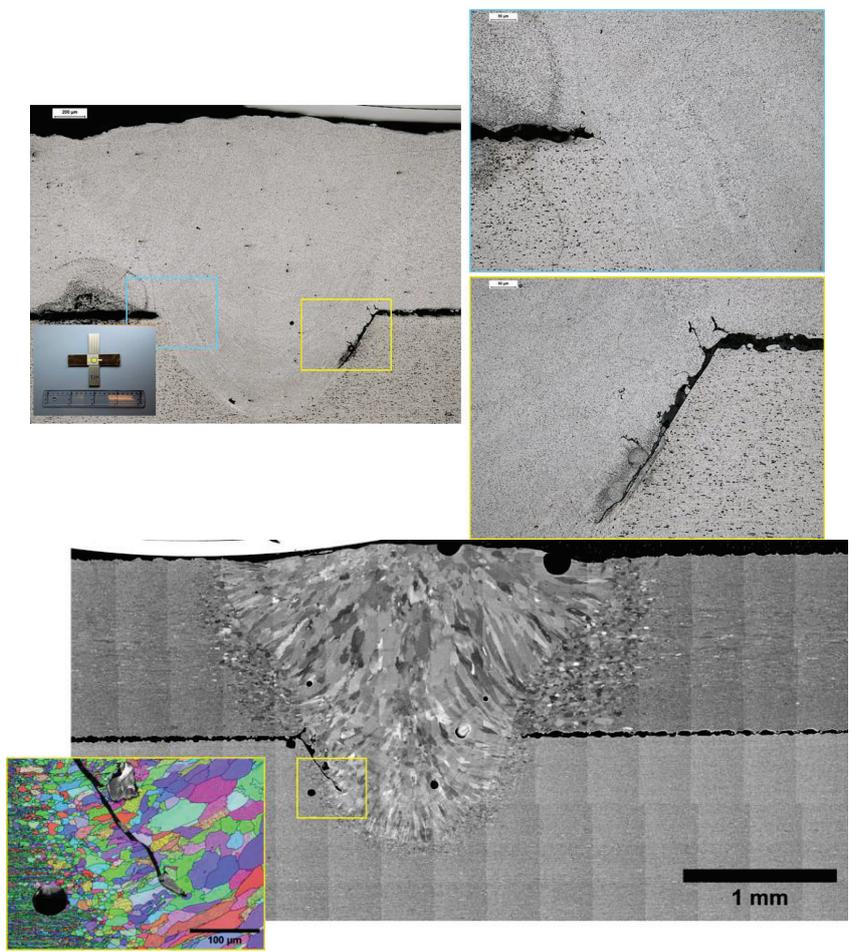
Figure 9 LOM image of a cross-section taken from the O-shaped weld after fatigue testing (top left) with two higher magnification images showing the junction between the fusion line and the interface between the two sheets (top right). Forwardsattered (FSD) SEM image of the same weld (bottom) and EBSD IPF showing the crack tip (bottom left).

In the O-shaped weld, a fatigue crack also initiating from the junction between the fusion line and sheet interface can be observed propagating primarily along the fusion line in Figure 9.

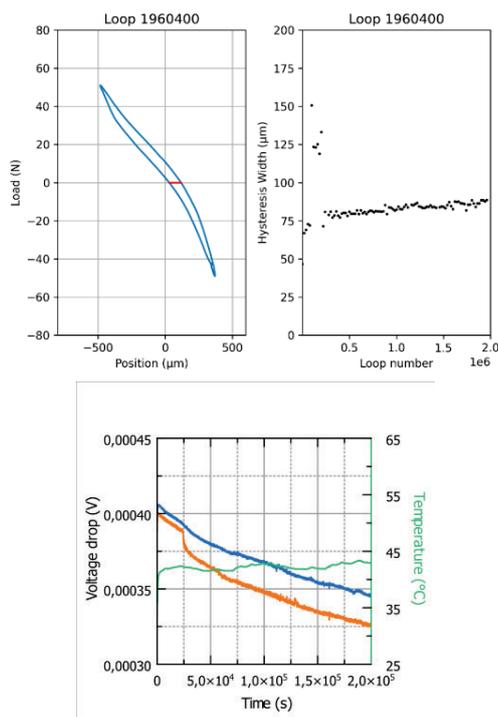
Figure 10 Force-displacement and hysteresis widths of an S-shaped weld subjected to fatigue under 300 A-DC (left). Voltage drop and temperature as measured by a thermocouple during fatigue testing (right).

The first tests with applied high current (300 A) during fatigue testing (50 N, 2 Mcycles) were done using an S-shaped weld from this set of weld specimens. The force-displacement data, voltage drop, and temperature during fatigue testing for this specimen can be seen in Figure 10. Here, the hysteresis width rose steadily but at a much lower rate compared to the S-shaped weld tested without high current. However, this is likely due to a surface defect on the low-current sample which led to the formation of the severe fatigue crack at the 1050 tab surface. Otherwise, the fatigue crack initiated at a similar location and followed a similar path along the fusion line/HAZ in the high-current sample compared to the low-current sample, although the fatigue crack in the high-current sample propagated further into the 3003 busbar.

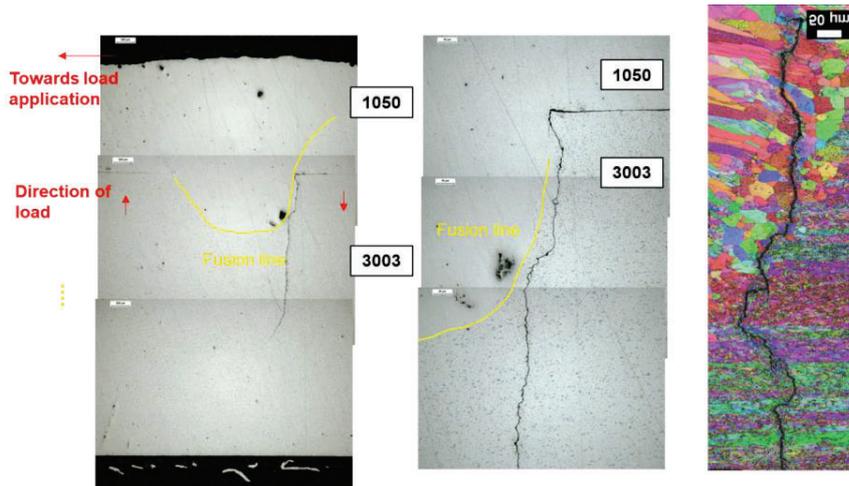
Figure 11 LOM micrographs showing the presence of a fatigue crack in the high-current S-shaped weld specimen (left and middle) and an EBSD IPF showing the crack propagation path (right).

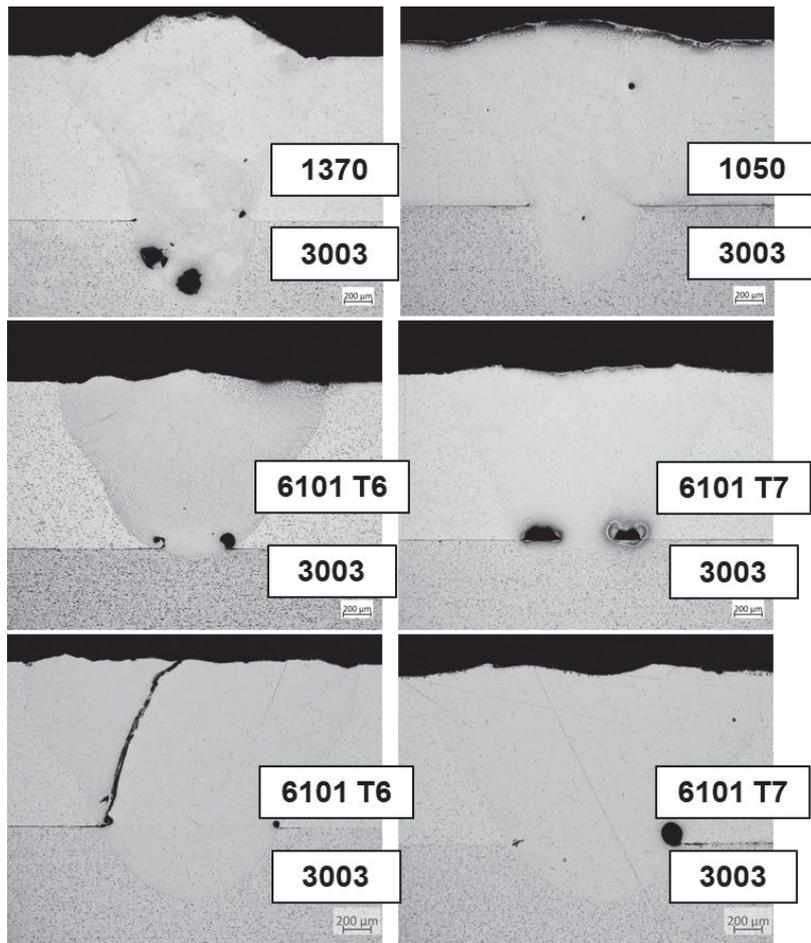
Figure 12 LOM micrographs of transverse cross-sections taken from the as-welded Lasertech samples.

Cross-sections of the as-received samples using different Al alloys as the tab material are shown in Figure 12 and Figure 13. In the 1xxx tab specimens, some porosity was observed, particularly in the weld root. In the initial trials, the 6101 tab specimens appeared to have insufficient penetration in the 3003 busbar (middle row of Figure 12), where some porosity can also be observed on either side of the weld where the fusion line meets the sheet interface. Therefore, new 6101 specimens were welded with higher heat input laser welding parameters. These parameters led to increased penetration (bottom row of Figure 12).

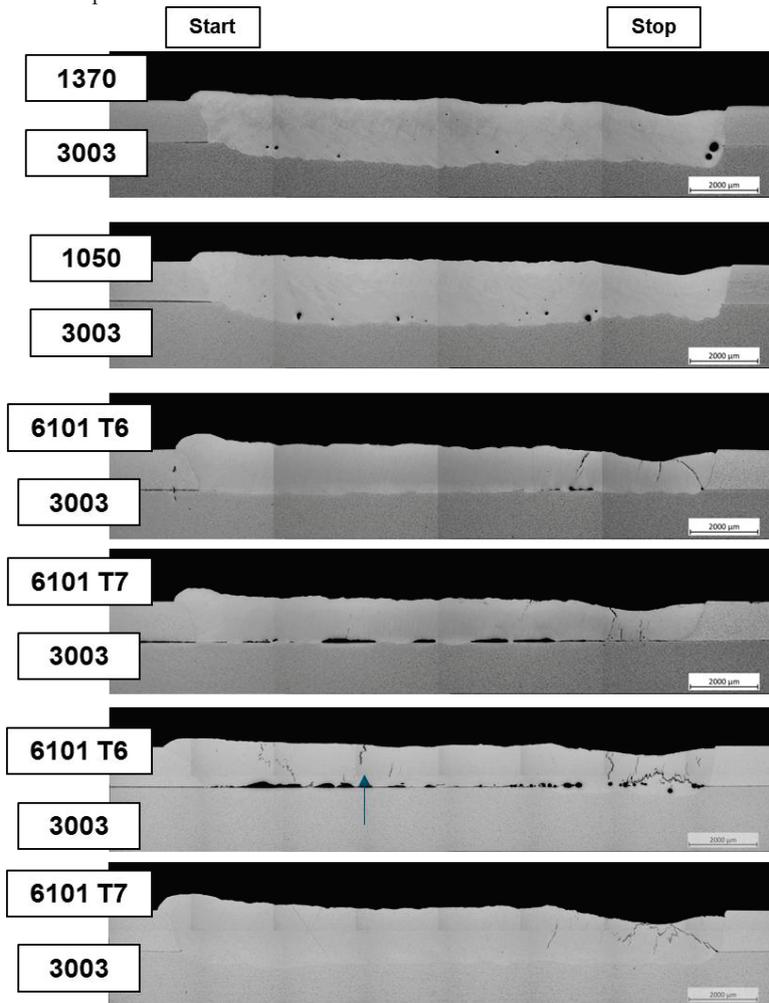
Figure 13 LOM micrographs of longitudinal cross-sections of laser-welded samples. Medium power, medium scanning speed

higher heat input laser welding parameters. Varying extents of solidification cracking were also observed in the end crater for all 6101 specimens, whereas the end crater regions of the 1xxx samples were crack-free.

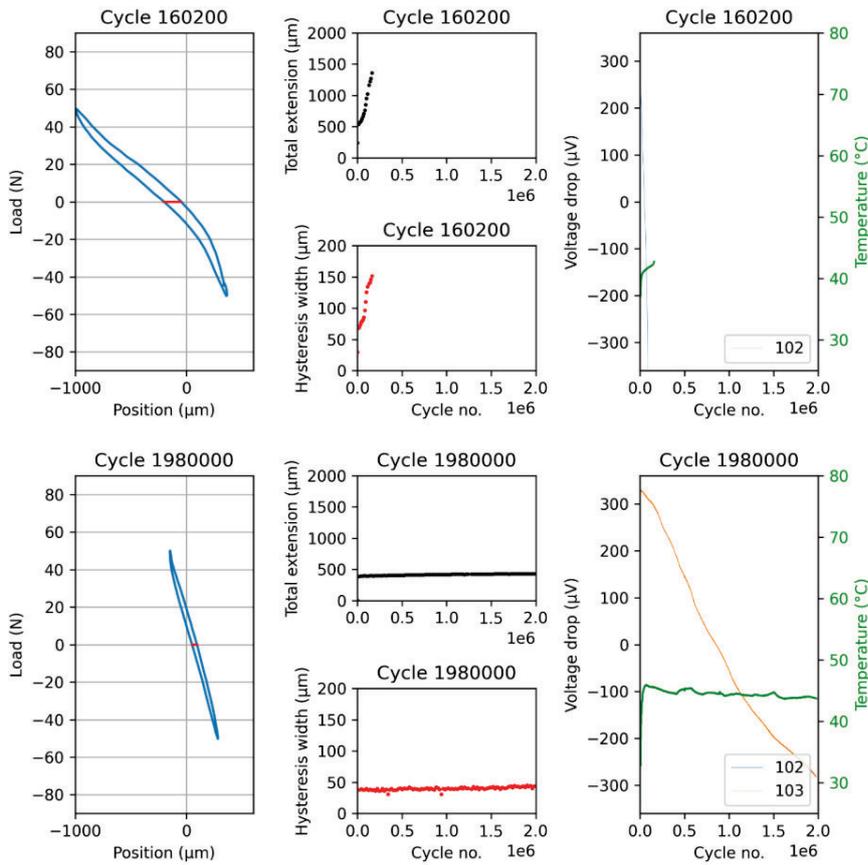
Figure 14 Force-displacement, voltage drop, and temperature for 1370 (top) and 1050 (bottom) samples subjected to 50 N load amplitude for 2 Mcycles under 300 A-DC applied current.

Force-displacement data during high-current (300 A-DC) fatigue testing for the 1370 and 1050 samples is shown in Figure 14. The total extension and hysteresis width of the 1370 tab sample was seen to rapidly rise, and the fatigue test was subsequently aborted via displacement auto-stop after only 160 kcycles. After removing the sample from the rig, it appeared that one of the two-line welds had fractured completely. The 1050 tab sample survived 2 Mcycles without triggering the displacement auto-stop, and the total extension and hysteresis width were relatively stable throughout the duration of the fatigue test.

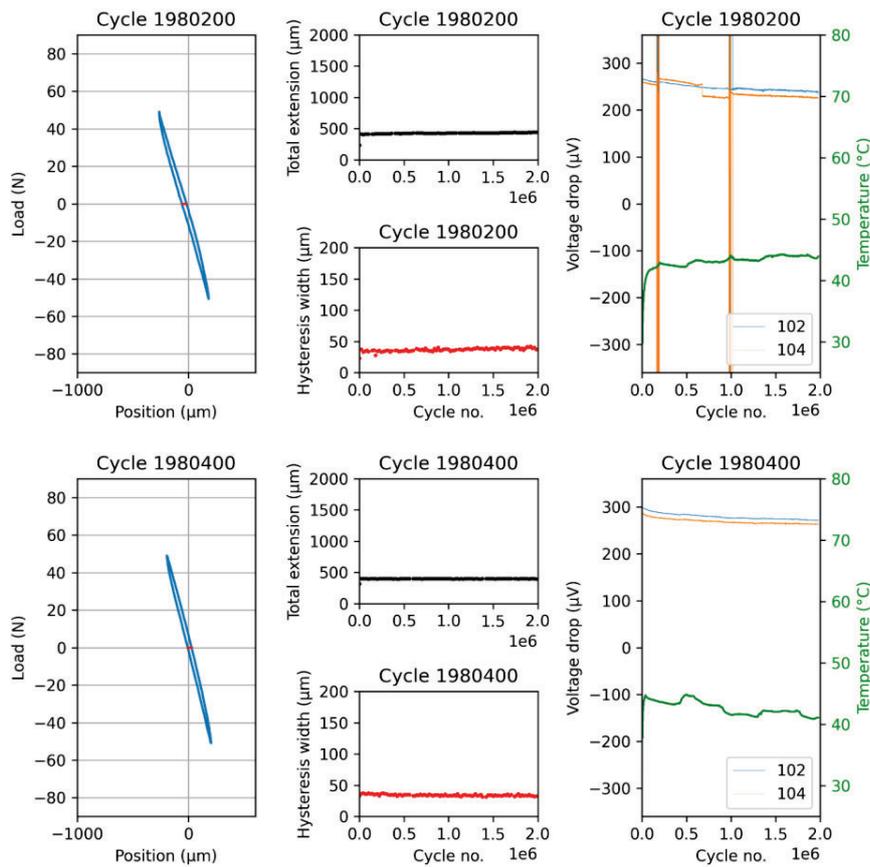
Figure 15 Force-displacement, voltage drop, and temperature for 6101 T6 (top) and 6101 T7 (bottom) samples subjected to 50 N load amplitude for 2 Mcycles under 300 A-DC applied current. Only the 6101 samples welded with high laser power and low scanning speed were fatigue tested.

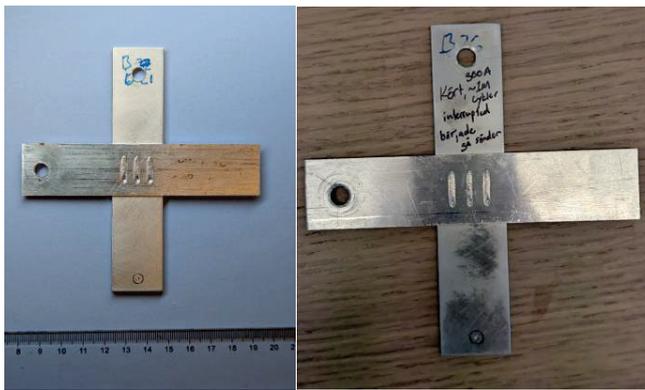
Figure 17 Photographs of the 1.4 mm weld width sample (left) and the 0.7 mm weld width sample (right).

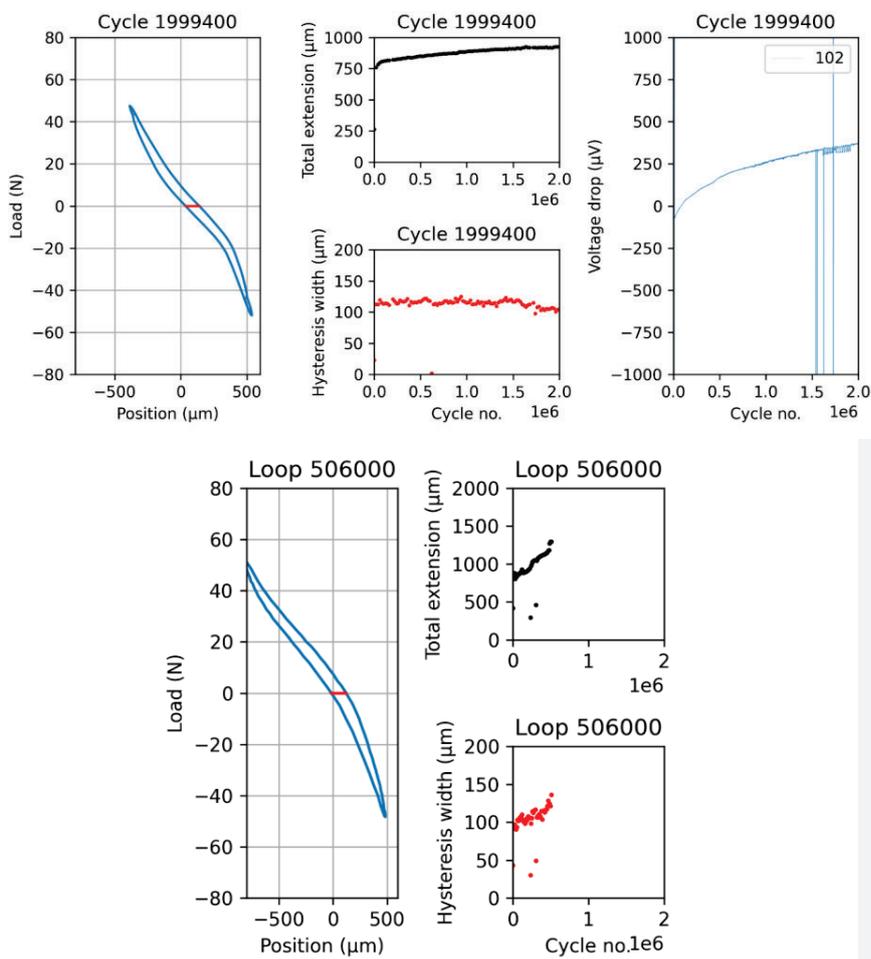
Figure 18 Load-displacement curves for the 1.4 mm weld width sample (top) and the 0.7 mm weld width sample (bottom). Voltage drop measurement was not available for the 0.7 mm weld width sample due to the fatigue test needing to be restarted several times.

These samples were subjected to 2 Mcycle, 50 N load amplitude under an applied 300 A-DC current. Load-displacement curves during fatigue testing can be seen in Figure 18. Although some asymmetry in the load-displacement loop was observed by the end of the fatigue test, the 1.4 mm weld width sample exhibited a stable hysteresis width with a somewhat increasing total extension during the 2 Mcycle. Given the increasing voltage drop, some fatigue damage was expected. The 0.7 mm weld width sample, however, gave a starkly degraded fatigue performance, triggering the autostop after only approximately 500 kcycle.

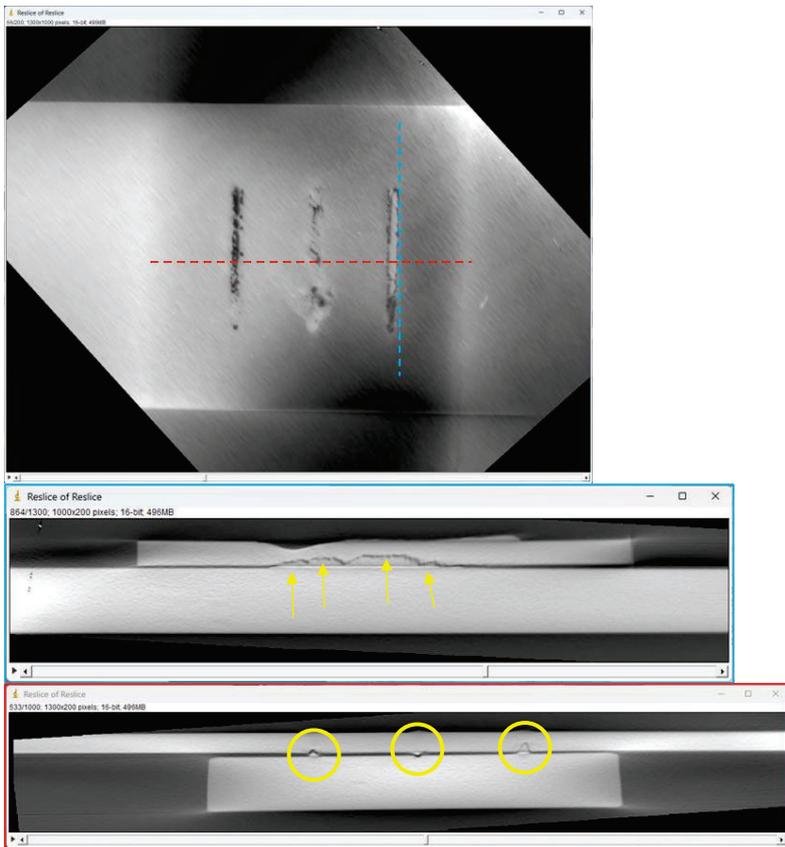
Figure 20 CT cross-sections from the top (top), longitudinal (middle) and transversal (bottom) of the 0.7 mm weld width sample after fatigue (2 Mcycles, 50 N load amplitude).

The 0.7 mm weld width sample (Figure 20) showed evidence of near catastrophic failure, with near-full material separation along most of the weld length primarily in the outer two welds. The centre weld also exhibited fatigue damage. In the outer two welds, it can be seen from the transverse cross-sections that the fatigue cracks appear to follow the direction of the assumed columnar grains (roughly 45°-60°) before meeting in the centre of the fusion zone.

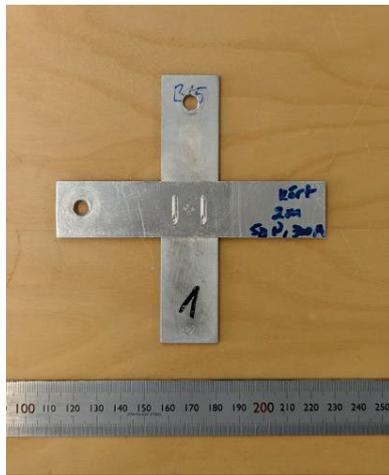
Figure 21 Photograph of the two-weld sample (1 mm weld width).

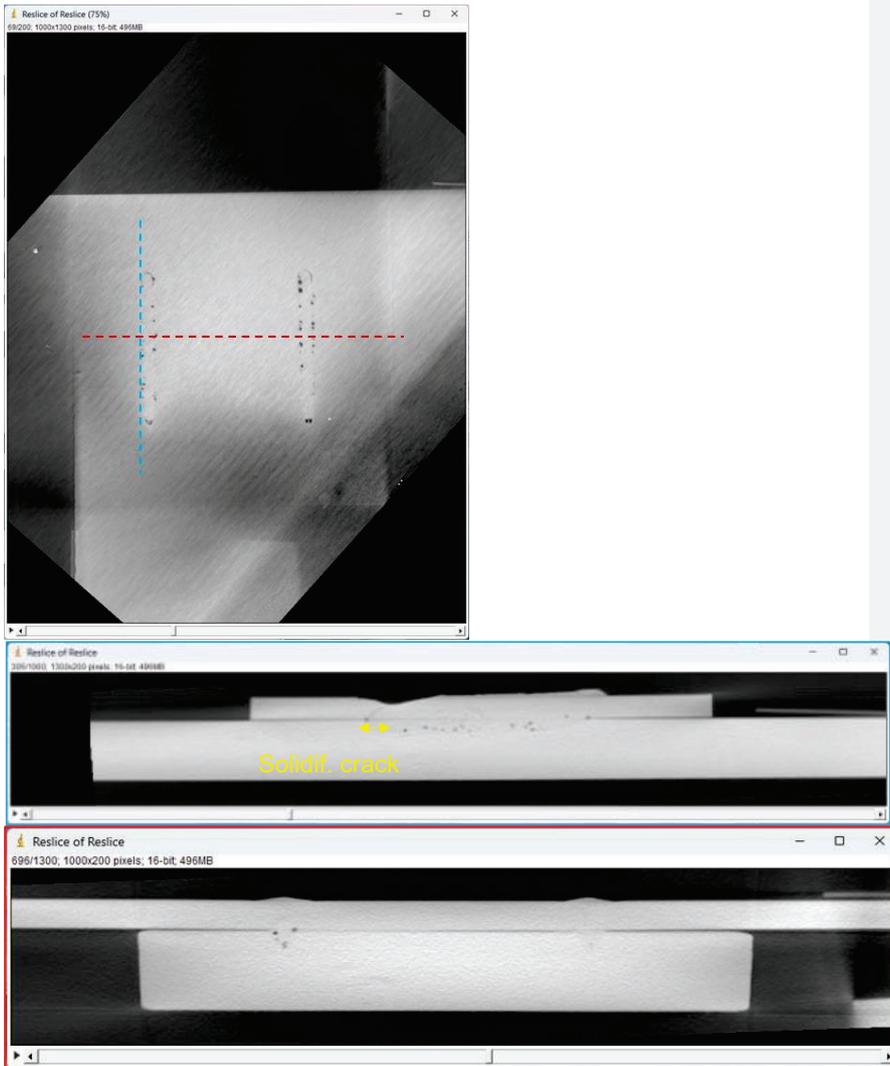
Figure 23 CT cross-sections from the top (top), longitudinal (middle) and transversal (bottom) of the two-weld 1 mm weld width sample after fatigue (2 Mcycles, 50 N load amplitude).

CT cross-sections of the two-weld 1 mm weld width sample after fatigue testing are shown in Figure 23. Moderate porosity was observed along the weld toes of both welds, and solidification cracking was also detected in both end craters. However, no obvious fatigue damage was identified in this sample.

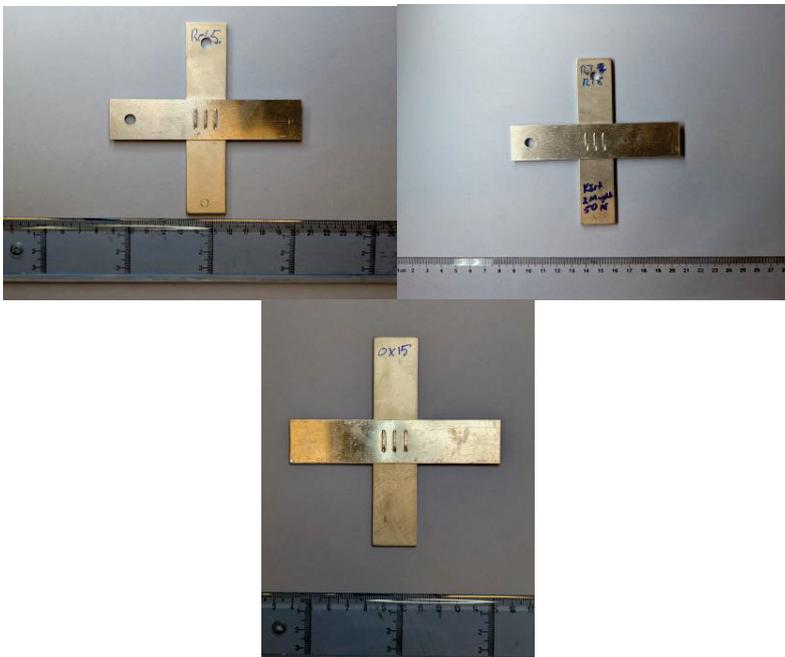
Figure 24 Photographs of representative samples of the reference condition, room-temperature oxidized (RT), and elevated temperature-oxidized (OX) laser-welded samples.

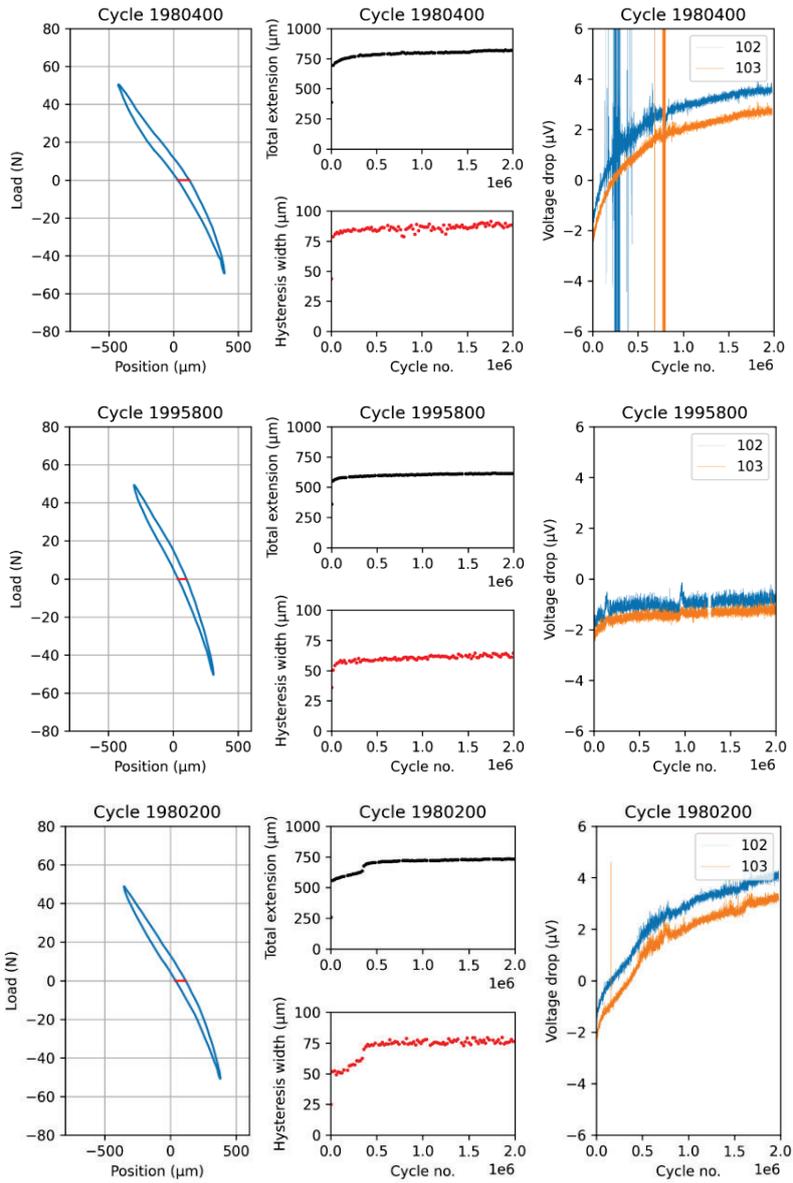
Figure 25 Load-displacement curves for a reference sample (top), RT sample (middle) and OX sample (bottom). 2 Mcycles, 50 N load amplitude. In addition to hysteresis width at zero load, the total extension from tip-to-tip is given. A measuring current of 3 A-DC was applied during testing.

Clear signs of fatigue damage were observed in the reference and OX samples subjected to cyclic loading (Figure 27 and Figure 31), where fatigue cracks were seen to initiate from the existing solidification cracks in the end crater region and propagate along the outer weld edge on the outer two welds. Although solidification cracks were present in the end craters on all welds, including the centre weld, fatigue damage was not observed in any of the centre welds. Despite experiencing the same cyclic load as the reference and OX samples, no fatigue damage was identified in the RT sample. This observation may indicate that the qualitatively higher amount of porosity along the weld edge in the RT sample compared to the reference sample is less critical for fatigue performance than solidification cracking in the end crater or the notch-like effect of the sheet interface. The lack of fatigue damage may also explain the more stable voltage drop across the RT sample compared to the other two samples as seen in Figure 25.

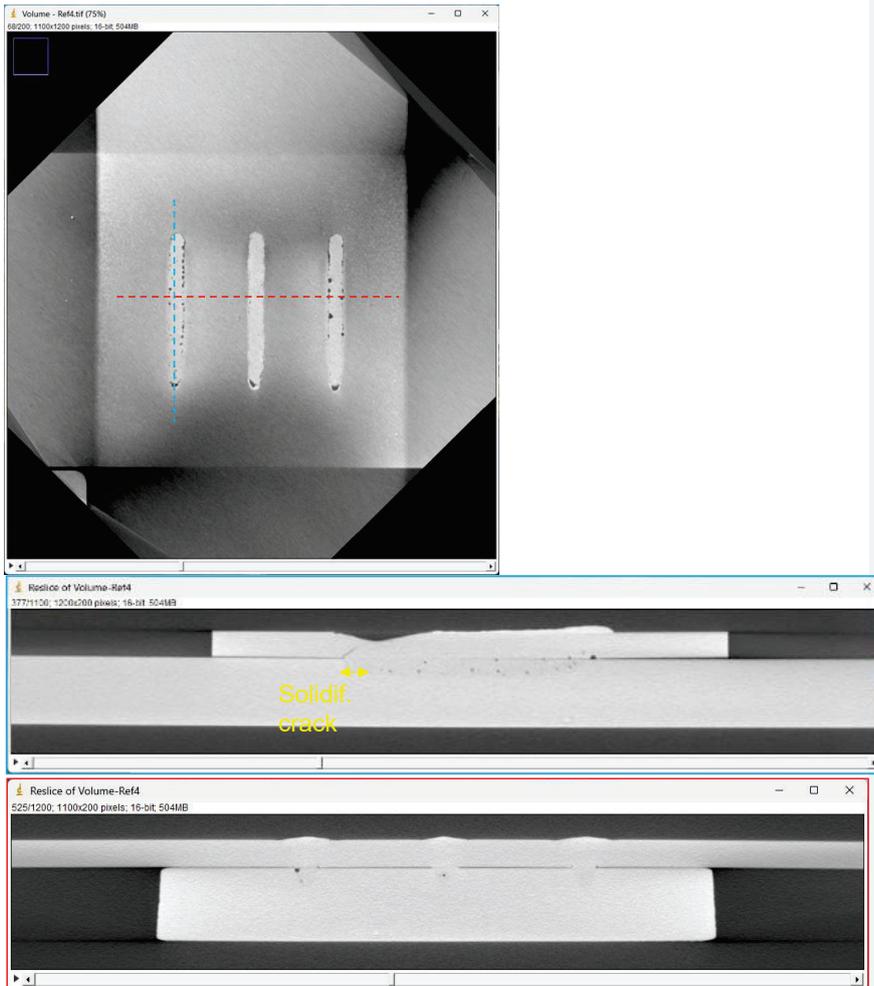
Figure 26 CT cross-sections from the top (top), longitudinal (middle) and transversal (bottom) of the reference 4 sample as-welded.

To further investigate the effect of oxidation on weld quality aspects, such as the presence of porosity, and the subsequent impact on fatigue performance, CT scanning was performed on as-welded and fatigue-tested samples. Cross sections from three different directions are shown for each condition in Figure 26-Figure 31. One common feature across all sample conditions was the presence of solidification cracking in the end crater of all three welds on each specimen. This is likely due to an unoptimized weld stop imparting high cooling rates and therefore high shrinkage stresses acting on a typically columnar grain structure. In addition to solidification cracking, another common defect is gas porosity. Pores were typically found along the edges of the weld in the interface between the two aluminium strips as well as in the root of the weld. Interestingly, welds located in the centre of the joint area always exhibited less porosity than the outer welds. In general, the RT and OX-treated samples tended to exhibit more and/or larger pores at the sheet interface compared to the reference samples. These observations are further discussed in Section **Error! Reference source not found.**

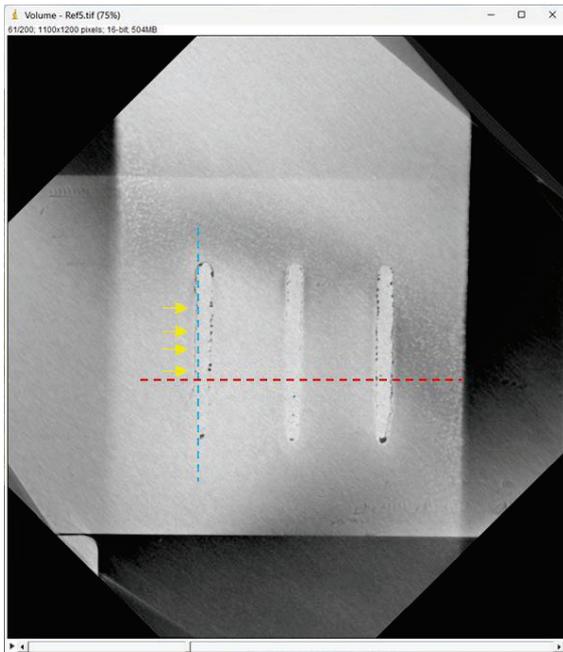
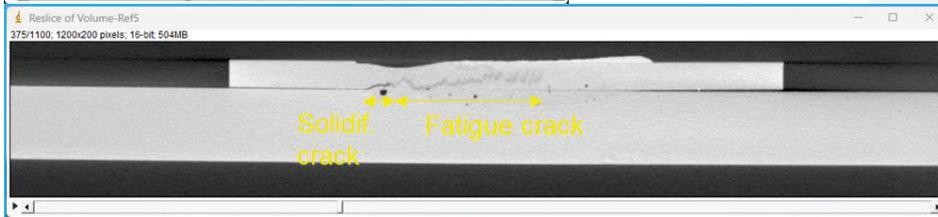
Figure 27 CT cross-sections from the top (top), longitudinal (middle) and transversal (bottom) of the reference 5 sample after fatigue (2 Mcycles, 50 N load amplitude).

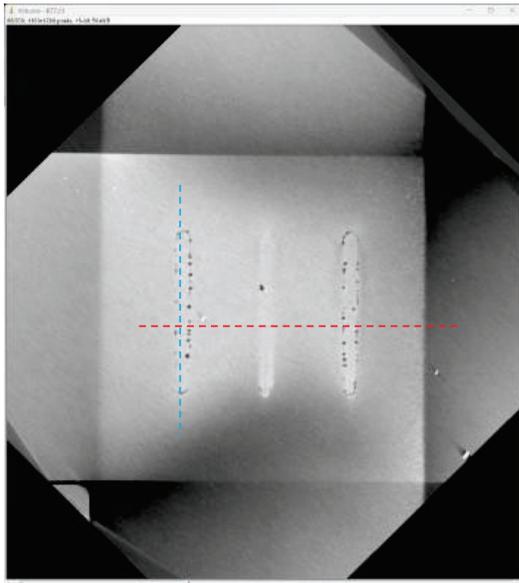
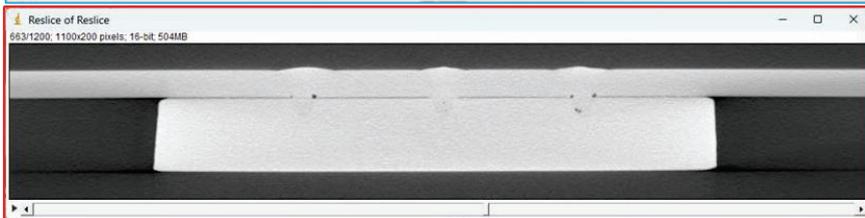
Figure 28 CT cross-sections from the top (top), longitudinal (middle) and transversal (bottom) of the RT7 sample as-welded.

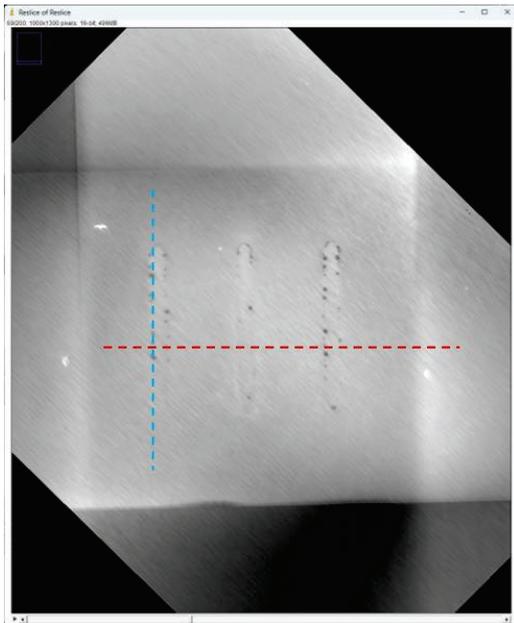
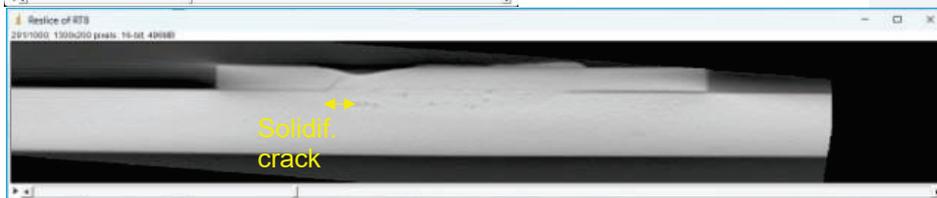
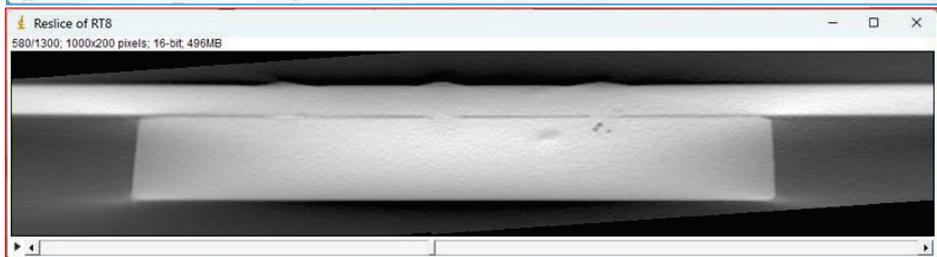
Figure 29 CT cross-sections from the top (top), longitudinal (middle) and transversal (bottom) of the RT8 sample after fatigue (2 Mcycles, 50 N load amplitude).

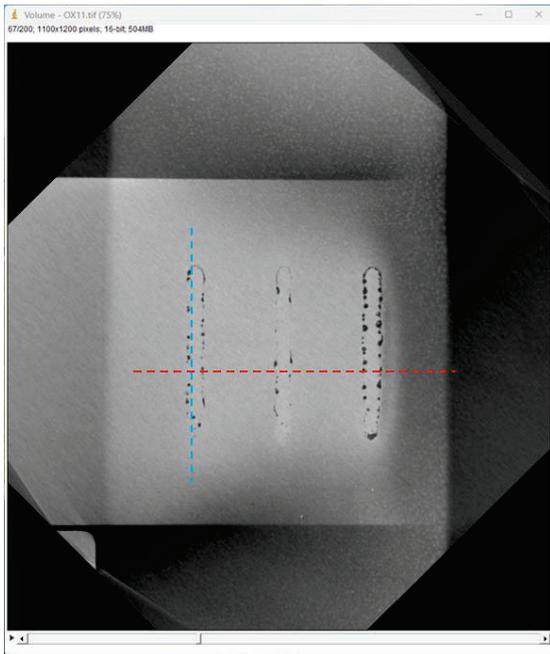
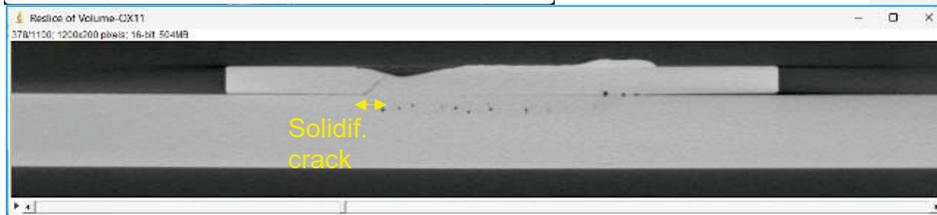
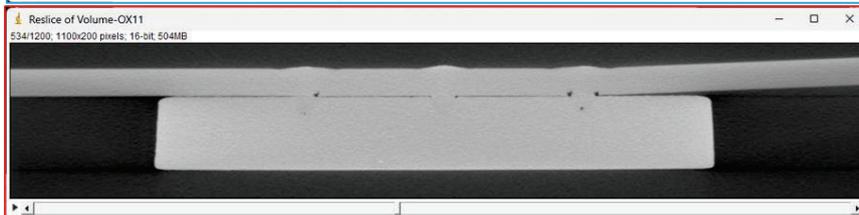
Figure 30 CT cross-sections from the top (top), longitudinal (middle) and transversal (bottom) of the OX11 sample as-welded.

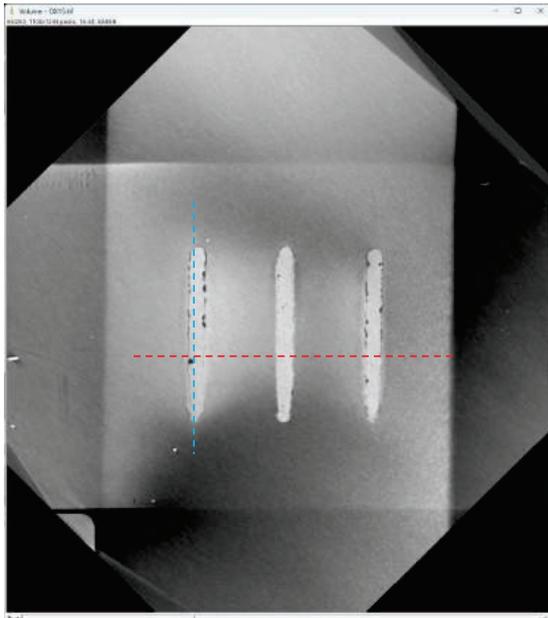
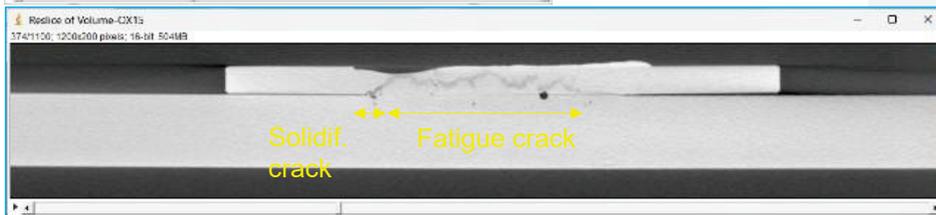
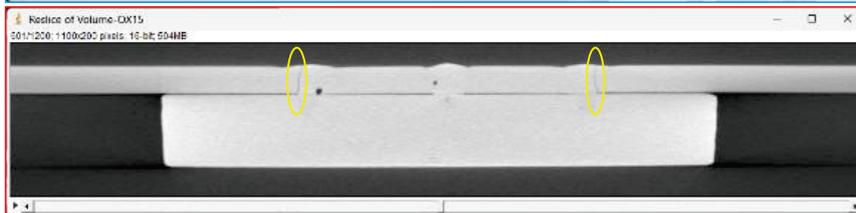
Figure 31 CT cross-sections from the top (top), longitudinal (middle) and transversal (bottom) of the OX15 sample after fatigue (2 Mcycles, 50 N load amplitude).

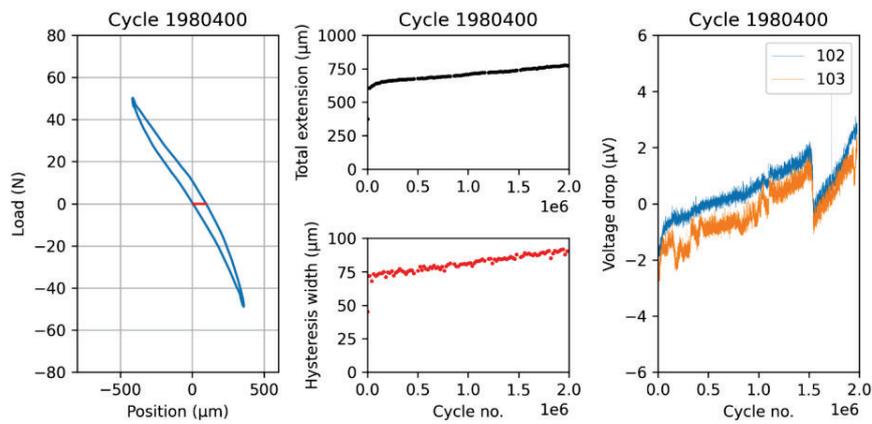
Figure 32 Load-displacement curves for the MJ17 soft-annealed sample. 2 Mcycles, 50 N load amplitude. In addition to hysteresis width at zero load, the total extension from tip-to-tip is given. A measuring current of 3 A-DC was applied during testing.

Another sample set tested in this case involved soft-annealing the 1050 aluminium “tab” before laser welding. The load-displacement curve during fatigue testing can be seen for the MJ17 sample in Figure 32. Although the sample survived the entire 2 Mcycle test without triggering the autopstop, a steadily increasing total extension and hysteresis width can be observed throughout the fatigue test, likely indicating accumulation of fatigue damage. The voltage drop (disregarding the interruption at ~1.5 Mcycle) also tended to steadily increase over the course of testing.

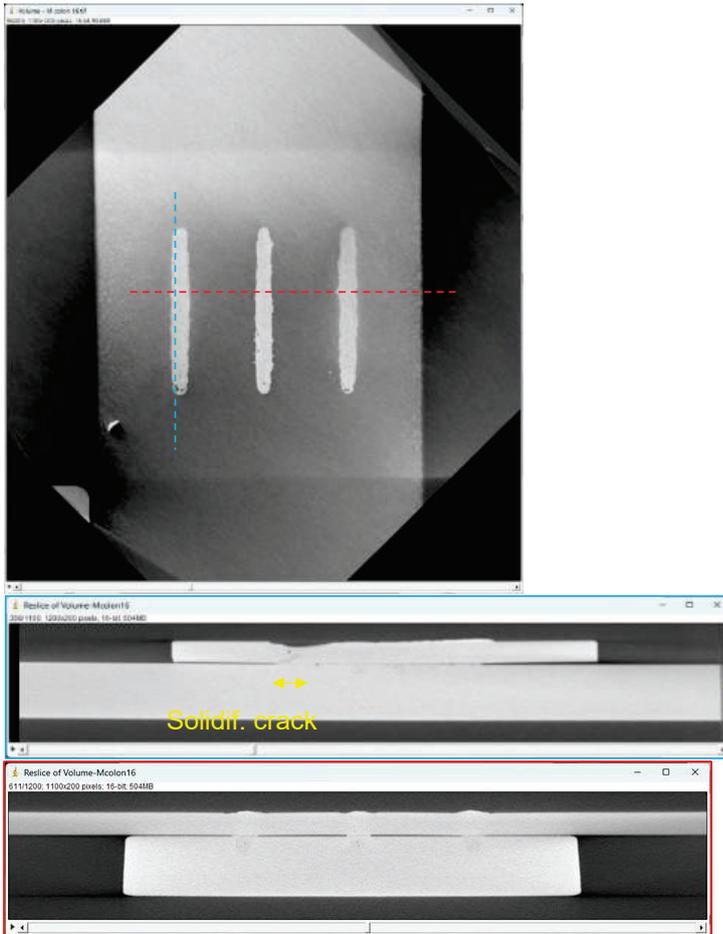
Figure 33 CT cross-sections from the top (top), longitudinal (middle) and transversal (bottom) of the MJ16 as-welded.

CT cross-sections for the as-welded MJ16 sample and the MJ17 after fatigue testing can be seen in Figure 33 and Figure 34. The as-welded sample exhibits noticeably less gas porosity along the weld toe compared to the reference and oxidized samples. However, solidification cracking was still present in the end crater of all three welds. After fatigue testing, fatigue cracking along the weld edges can be observed in Figure 34. In this case, the fatigue crack has even propagated through the base material. Although difficult to represent with 2D cross-sections, the fatigue damage within and near the fusion zone was found to be more extensive compared to the reference case. These likely causes behind these findings are discussed further in Section **Error! Reference source not found.**

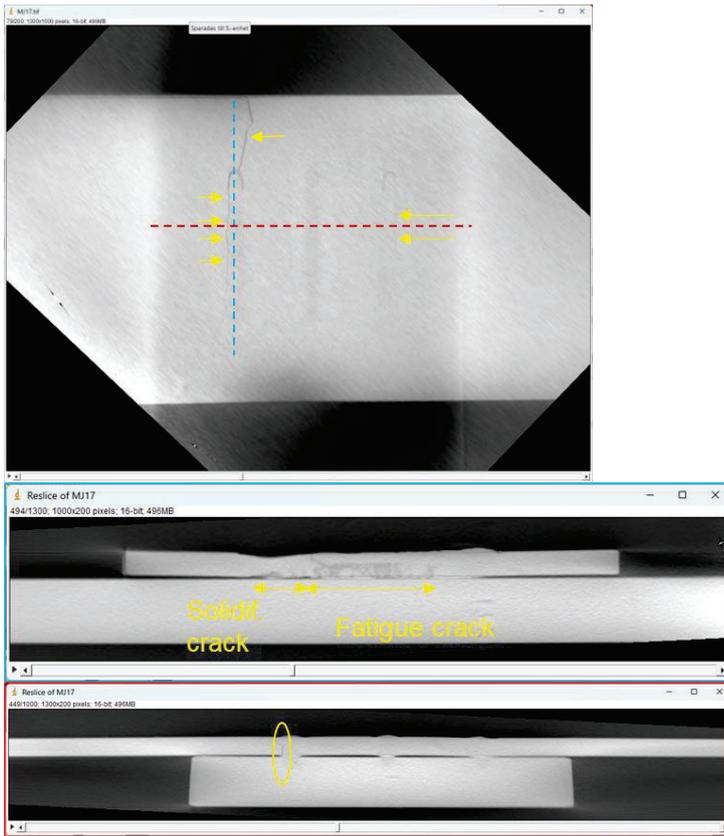
Figure 34 CT cross-sections from the top (top), longitudinal (middle) and transversal (bottom) of the MJ17 sample after fatigue (2 Mcycles, 50 N load amplitude).

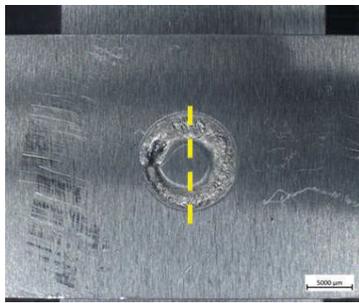
Figure 35 Macro photograph of one of the circular weld samples. The yellow line indicates the orientation of the cross-section taken for further characterization.

First, a representative circular weld was characterized in the as-welded condition. A photograph of the sample can be seen in Figure 35. A cross-section (Figure 36) was taken along the yellow line in Figure 35 to characterize the as-welded condition. This cross-section shows a weld profile that has noticeably more penetration and a narrow weld root compared to the other laser welding cases in this work.
