Electrical joints optimized for increased thermal and mechanical fatigue life

Public report

Project within Circularity - FFI - Juni 2022

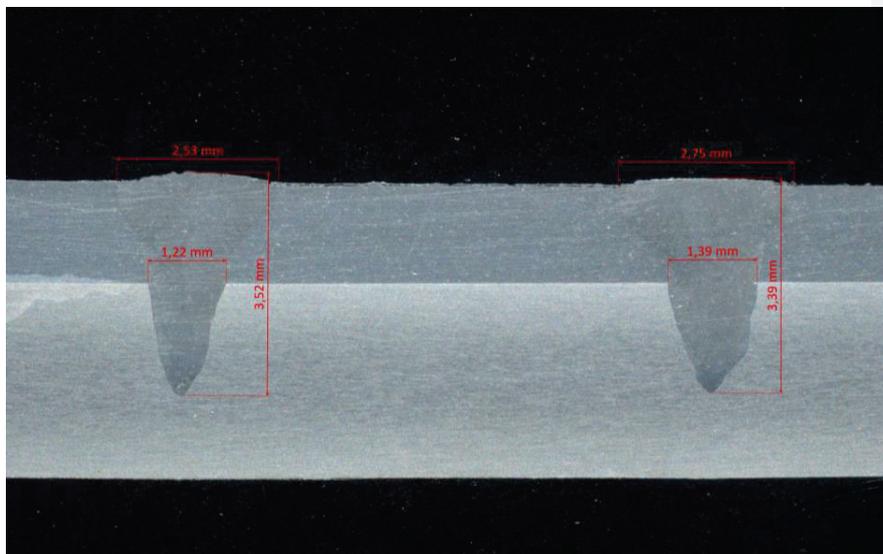
Figure 36 Macro photograph cross-section of the circular weld with penetration and weld width measurements.

First, a representative circular weld was characterized in the as-welded condition. A photograph of the sample can be seen in Figure 35. A cross-section (Figure 36) was taken along the yellow line in Figure 35 to characterize the as-welded condition. This cross-section shows a weld profile that has noticeably more penetration and a narrow weld root compared to the other laser welding cases in this work.

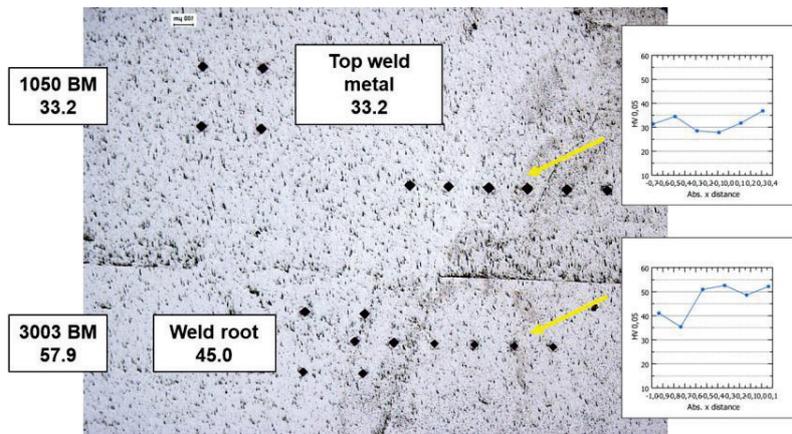
Figure 37 Micrograph of one side of the circular weld (left) with Vickers microhardness (HV0.05) data inset and hardness profiles taken from the fusion zone into the base metal.

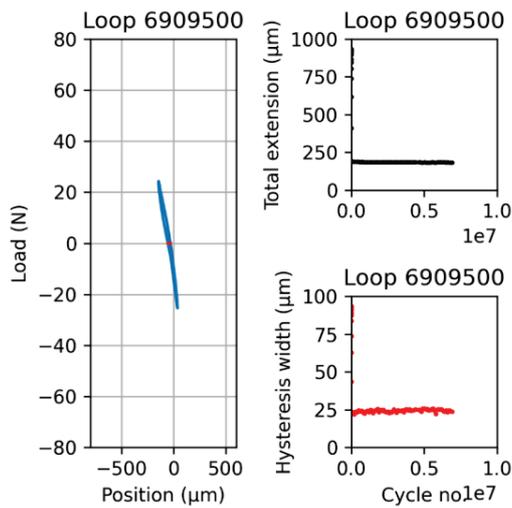
Figure 38 Load-displacement curves for a circular weld Volvo Cars sample. 10 kcycles at 80 N load amplitude followed by 7 Mcycles, 25 N load amplitude. In addition to hysteresis width at zero load, the total extension from tip-to-tip is given.

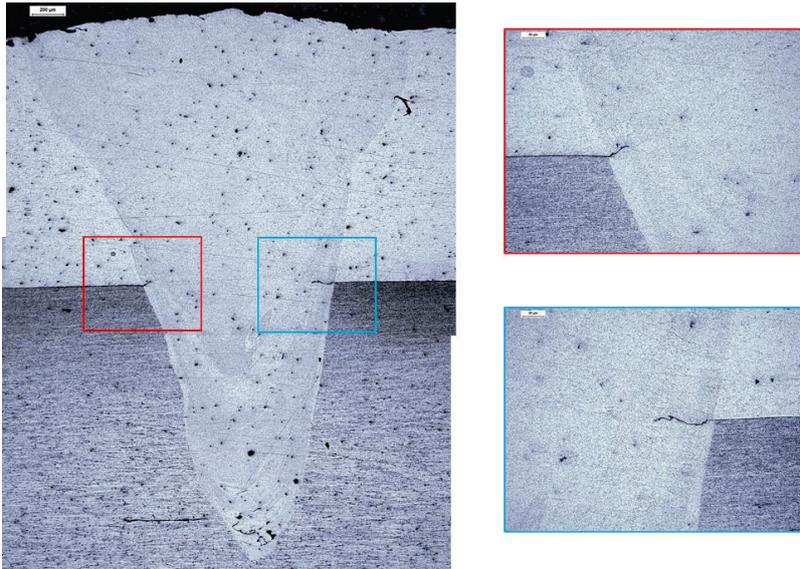
Figure 39 LOM micrograph of a circular weld cross-section after fatigue testing (10 kcycles at 80 N load amplitude followed by approximately 7 Mcycles at 20 N load amplitude).

After fatigue testing, these samples were cross-sectioned and investigated via LOM. A representative cross-section is shown in Figure 39. Here, fatigue damage was limited to rather short cracks which initiated at the junction between the fusion line and the sheet interface, and which then propagated into the weld metal. Given the stability of the hysteresis loop during the 25 N load amplitude stage, it seems reasonable to assume that the bulk of the observed fatigue damage occurred during the 80 N load amplitude stage.

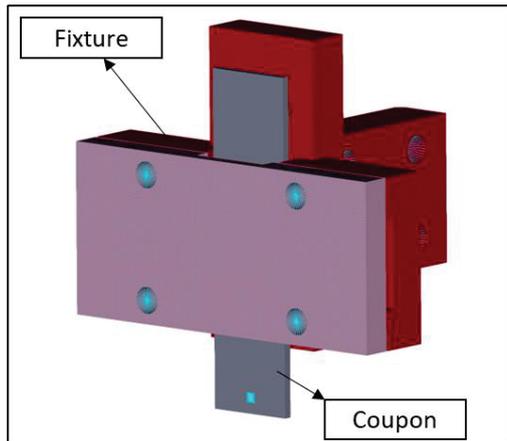
Figure 40 FEM model of the weld sample inside the fatigue testing rig.

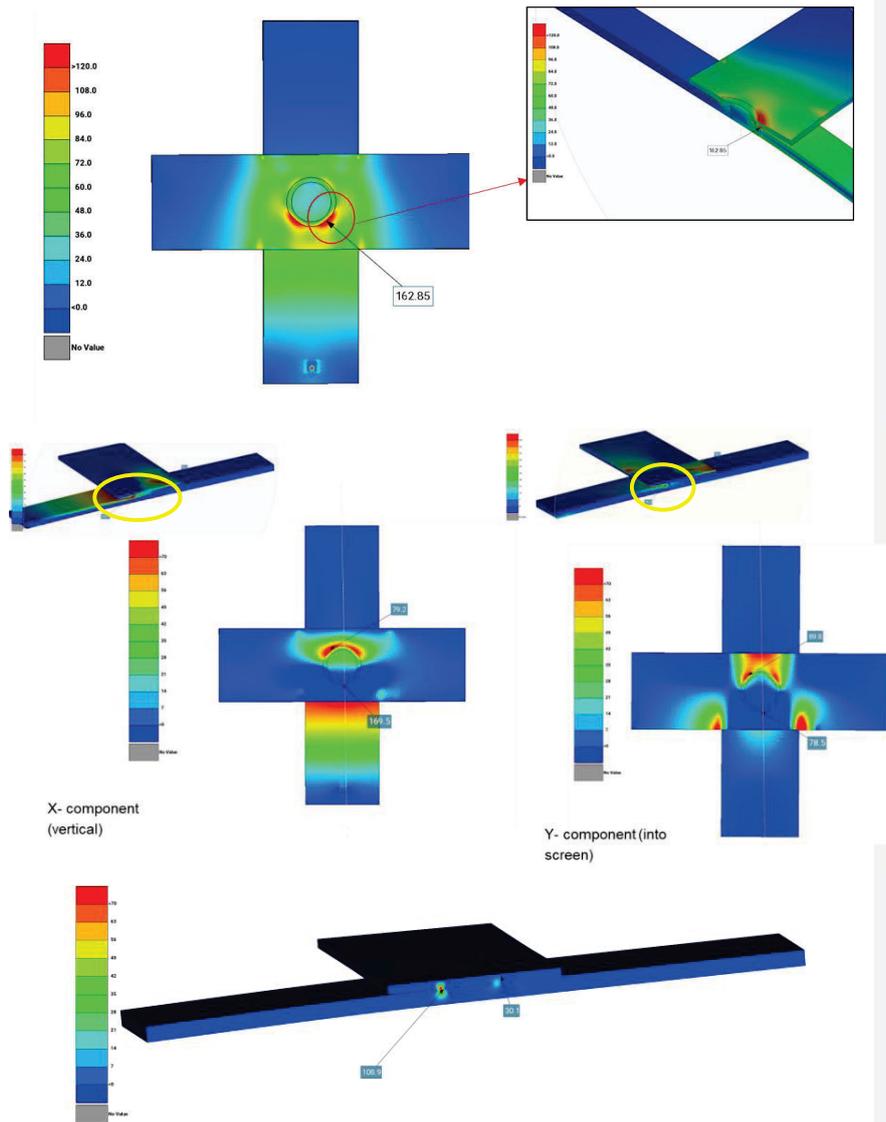
Figure 41 FEM results showing the von Mises stress (top), x-component (middle left), y-component (middle right), and z-component (bottom) of stress in the sample. Inset images show the distribution of each stress component along a cross-section.

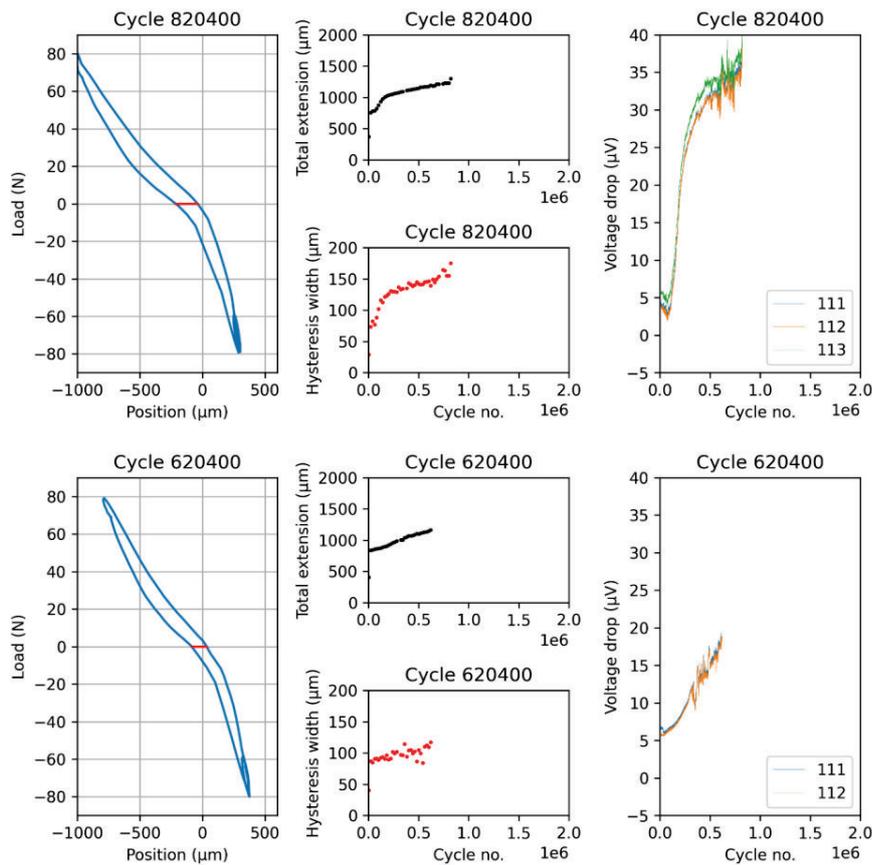
Figure 42 Load-displacement curves for circular weld Volvo Cars samples *as-welded (top) and after one month heat-treatment at 120 °C (bottom)*. 2 Mcycles at 80 N load amplitude. In addition to hysteresis width at zero load, the total extension from tip-to-tip is given. A measuring current of 3 A-DC was applied during testing.

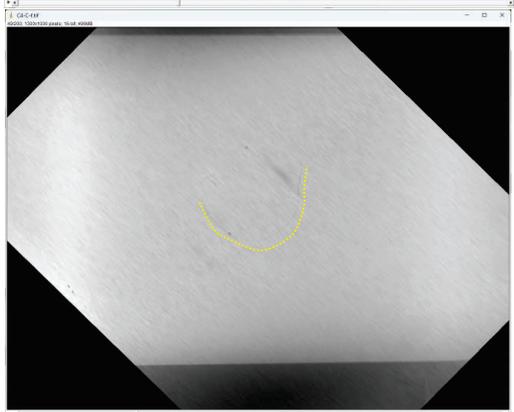
Figure 43 CT cross-sections from the top in the sheet interface (top), approximately in the middle of the 1050 piece (second from top), transverse vertical (third from top, blue) and transverse horizontal (bottom, red) of the 1 month heat-treated sample (2 Mcycles, 80 N load amplitude).

CT cross-sections of the heat-treated sample after fatigue testing are shown in Figure 43 (the as-welded sample was still being tested when the last round of CT scanning was performed and is therefore not available). Significant fatigue damage accumulated in the lower half of the circular weld, which is in good agreement with the stress distribution predicted by the FEM simulation. The fatigue crack was also found to branch off into the 1050 base material on the right side of the weld (second image from top in Figure 43). In the transverse cross-sections, it was seen that the fatigue crack primarily propagates through the fusion from both sides of the junction of the fusion line with the sheet interface.

Additionally, thin fatigue cracks propagating vertically along the weld depth (blue image in Figure 43) were observed.

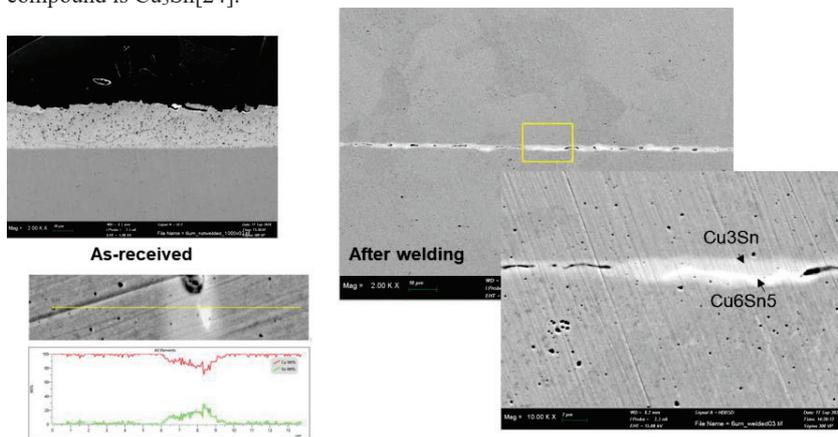
Figure 44 SEM images of the 6 μm tin coating (Provider 1) on the copper before welding (top left) and the intermetallic layer formed between the two coated copper pieces after welding (right). An EDS line scan of the intermetallic layer is shown on the bottom left.

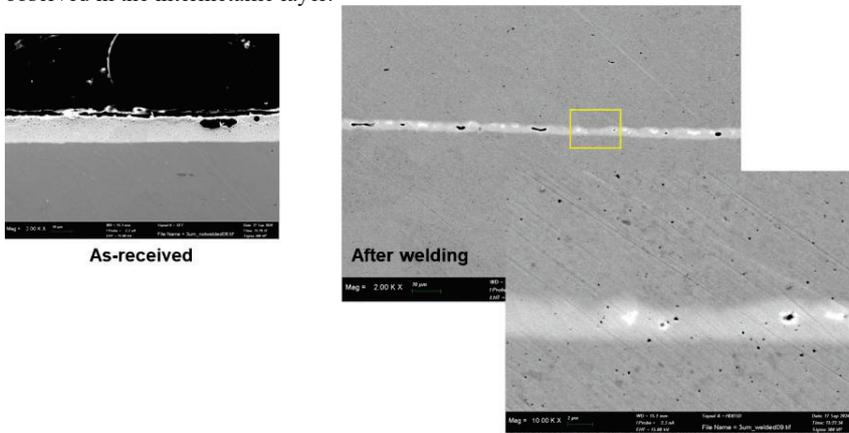
Figure 45 SEM images of the 3 μm tin coating (Provider 1) on the copper before welding (top left) and the intermetallic layer formed between the two coated copper pieces after welding (right).

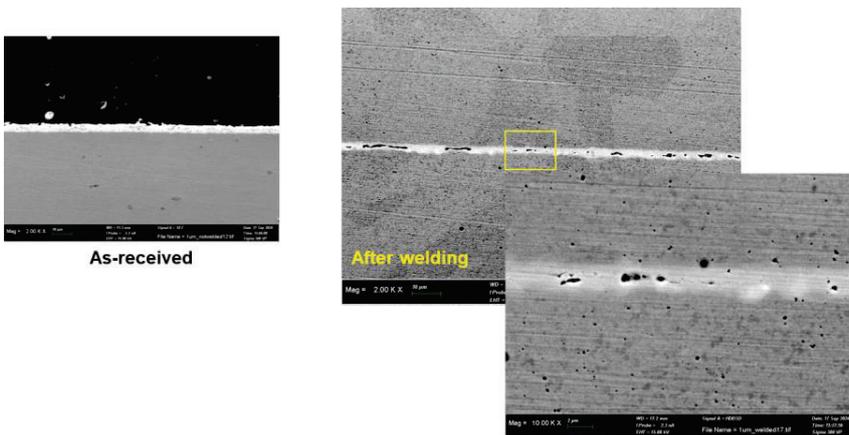
Figure 46 SEM images of the 1 μm tin coating (Provider 1) on the copper before welding (top left) and the intermetallic layer formed between the two coated copper pieces after welding (right).

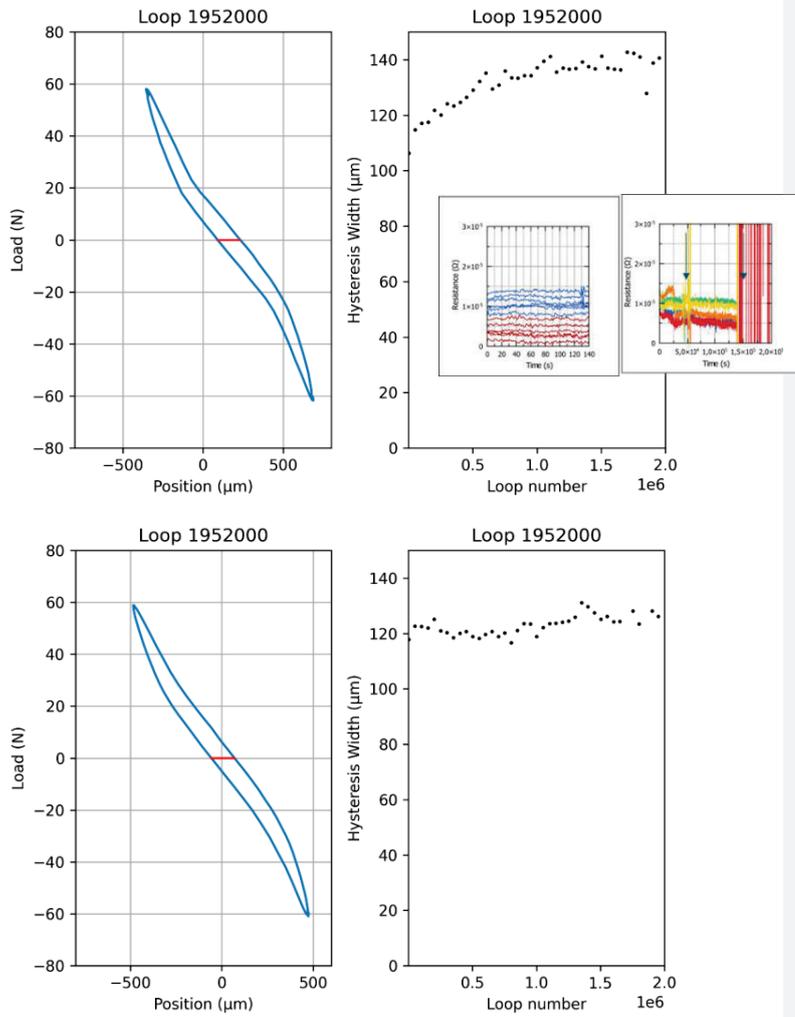
Figure 47 Load vs. displacement loops and hysteresis width for nominal 1 μm-thick tin coating (actual 4.1 μm, Provider 1, top) and nominal 6 μm-thick tin coating (actual 21 μm Provider 1, bottom). 2 Mcycles, 60 N load amplitude. The inset graphs at the top show the voltage drop with and without reversed polarity before testing (left) and the voltage drop during testing (right).

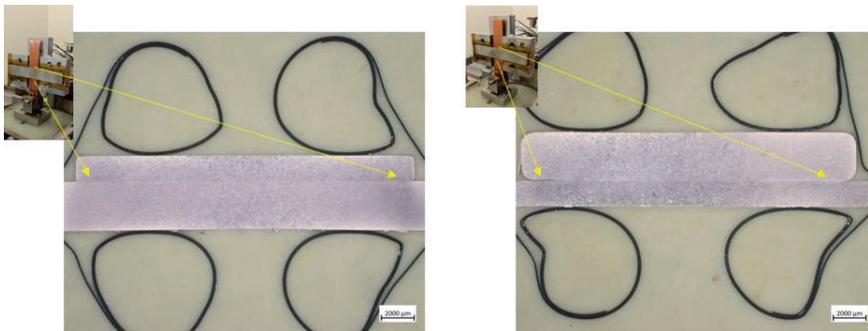
Figure 48 Macro cross-sections of samples with nominal 1 μm -thick tin coating (actual 4.1 μm , Provider 1) as-welded (left) and after 2 Mcycle of fatigue at 60 N load amplitude (right).

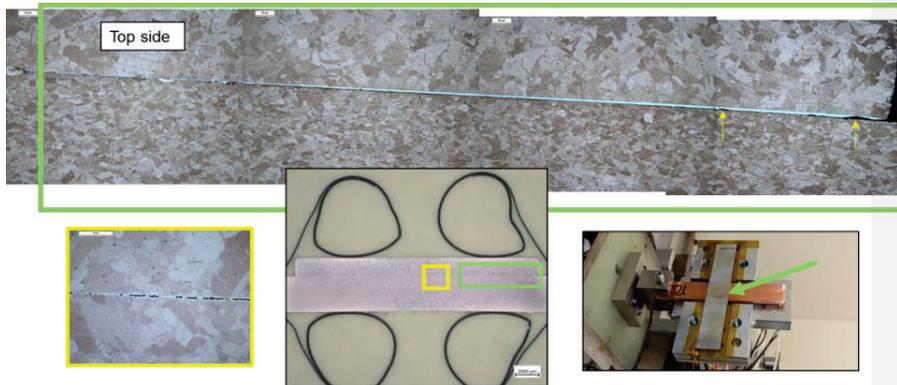
Figure 49 Stitched LOM micrograph of the weld interface for the nominal 1 μm -thick tin coating sample (actual 4.1 μm , Provider 1) in the as-welded condition. Higher magnification micrograph of the weld interface (bottom left). Photograph showing the location of the micrographs (bottom center). Orientation of the sample in the fatigue testing rig (bottom right).

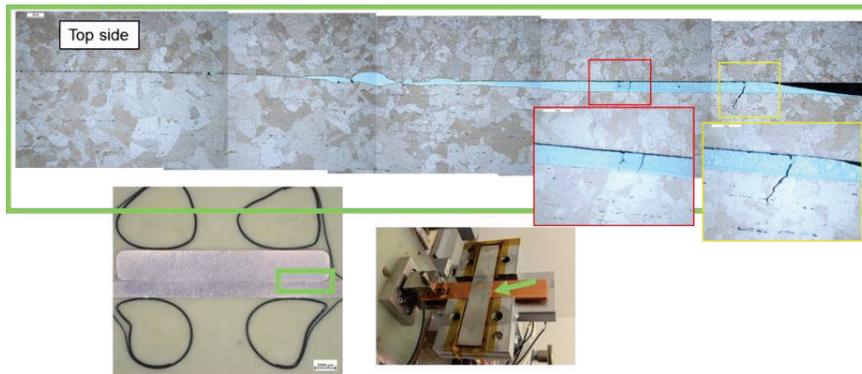
Figure 50 Stitched LOM micrograph of the weld interface for the nominal 1 μm -thick tin coating sample (actual thickness 4.1 μm , Provider 1) after 2 Mcycles, 60 N load amplitude fatigue testing. Higher magnification micrograph of the weld interface (bottom left). Photograph showing the location of the micrographs (bottom center). Orientation of the sample in the fatigue testing rig (bottom right).

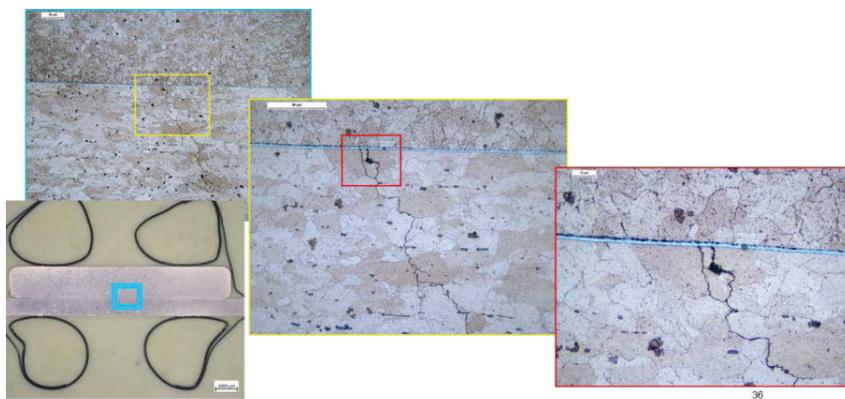
Figure 51 Higher magnification LOM images of the nominal 1 μm -thick tin coating sample (actual thickness 4.1 μm , Provider 1) subjected to fatigue.

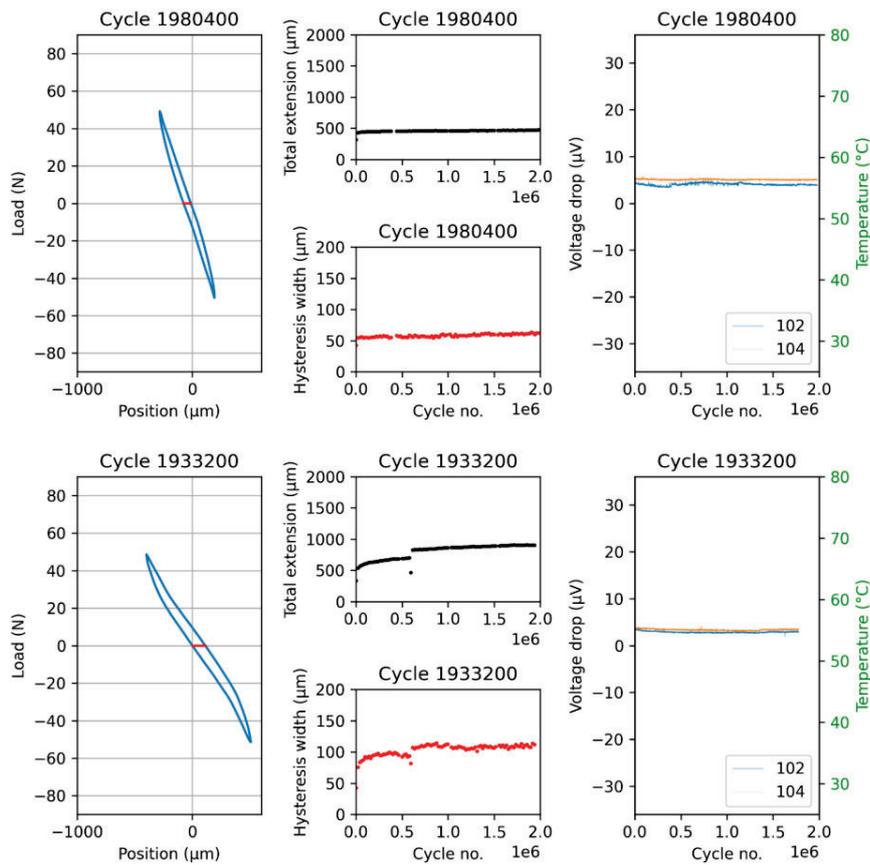
Figure 52 Load vs. displacement loops and hysteresis width for 1 μm -thick tin coating (Provider 2, top) and 6 μm -thick tin coating (Provider 2, bottom). 2 Mcycles, 50 N load amplitude.

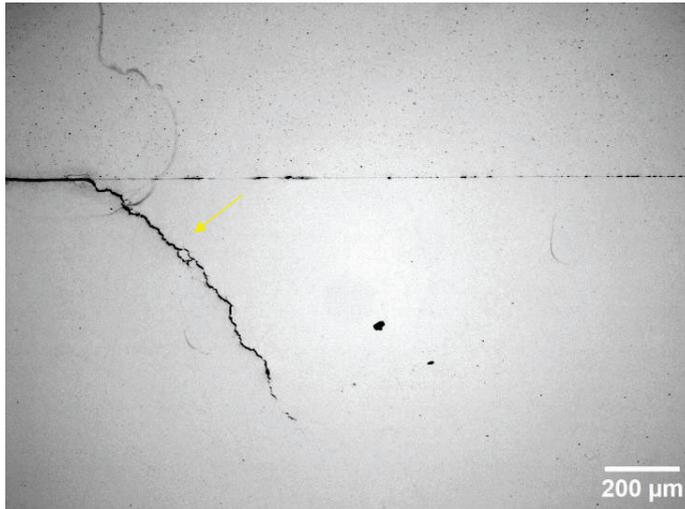
Figure 53 LOM micrograph of the 6 μm coating sample (Provider 2) after fatigue testing for 2 Mcycle at 50 N load amplitude.

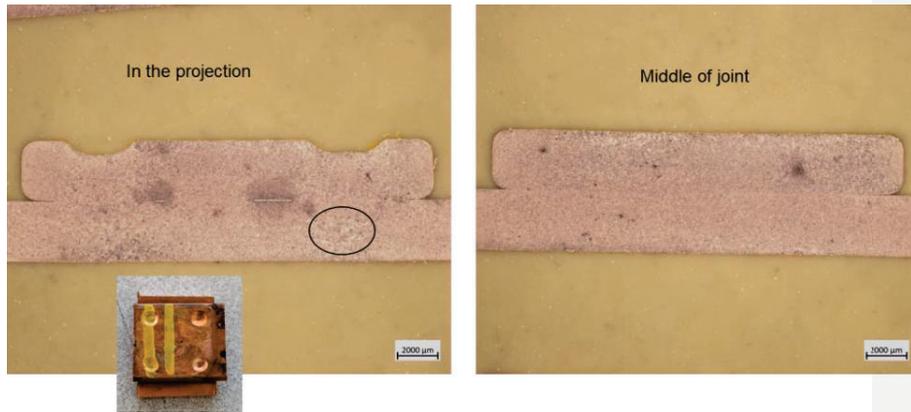
Figure 54 Macro cross-sections of a projection-welded copper sample. The cross-section on the left was taken from the middle of the projections, whereas the cross-section on the right was taken from the middle of the welded joint (see inset photograph).

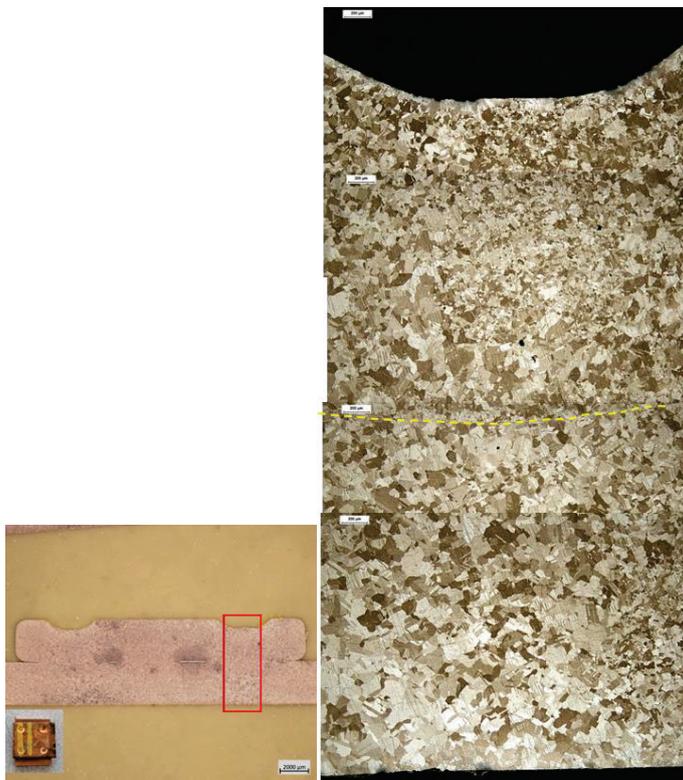
Figure 55 Stitched LOM image (right) of the weld-affected zone in a projection-welded copper sample. The red box in the photograph on the left shows the area of the stitched image.

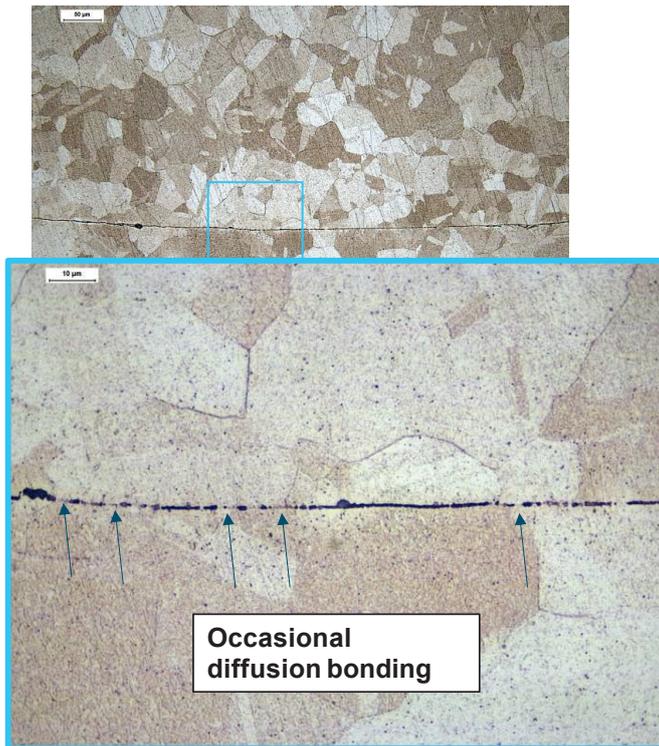
Figure 56 Higher magnification LOM images of the projection weld interface showing indications of the formation of a diffusion bond between the two copper strips.
