Robust Polishing of environmentally friendly coatings and their dependence on the substrate for lightweight materials in the automotive industry

Project within Sustainable Production

Author: Frida Willhammar

Date: 2014-04-21

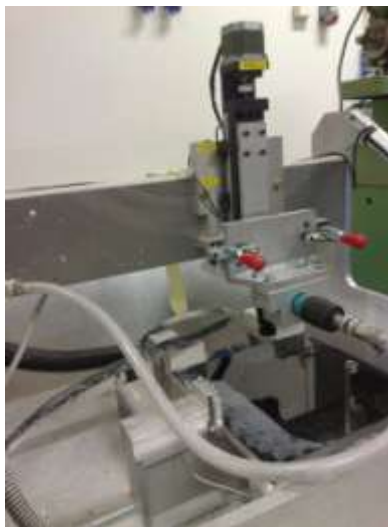
The polishing-rig developed at Volvo Cars where different clear coats and polishing strategies can be tested in a systematic way.

The possibilities to systematically test coating systems are expected to result in a better understanding of polishing mechanisms and what factors are the most influencing ones for the tribo-system. Further, the problems with new coating concepts in production will be reduced and the dependence of suppliers' 'blackbox solutions' will decrease. A first version of a polishing-rig developed at Volvo Cars has been successfully used to test and evaluate different polishing strategies for clear coats. The WMS well as other measurement equipment (e.g. interferometry) will be available and used in order to estimate surface appearance and study scratch patterns and other polishing defects in more detail.
